DWB Consulting Services Ltd.

Cottonwood River Protection Works Assessment

Prepared for: Cariboo Regional District
Attn: Stephanie Masun, Alyson Campbell

Prepared by: DWB Consulting Services Ltd.
1579 – 9th Avenue
Prince George, BC V2L 3R8
250.562.5541 | www.dwbconsulting.ca
Date: 31.08.2022 | DWB file: 22619-137 PE | Revision: 1

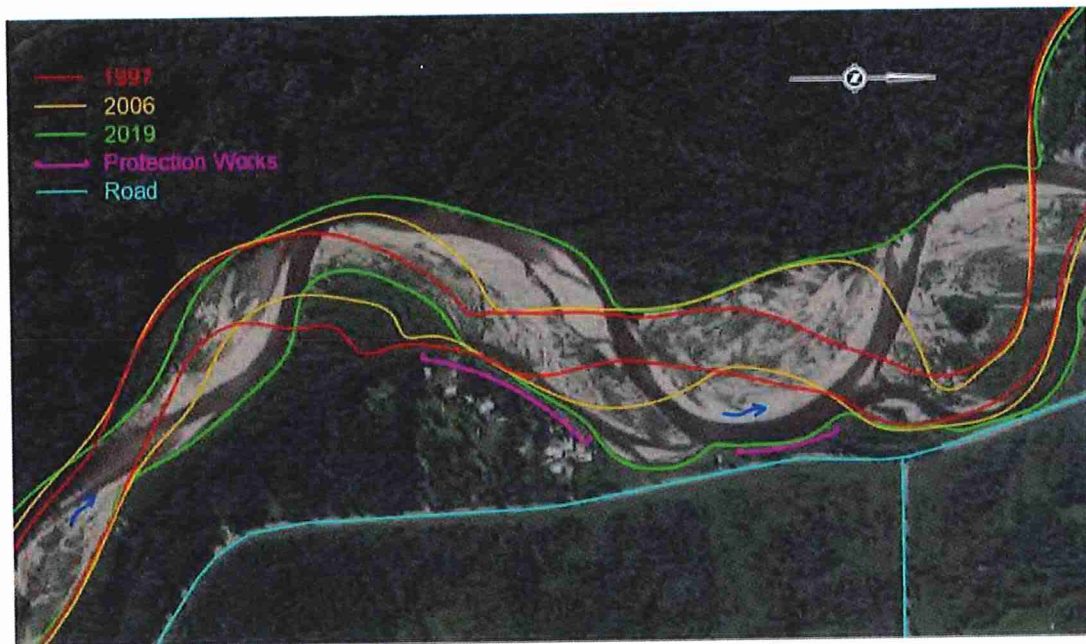
Figure 2: Cottonwood River Channel Morphology

It can be seen in this comparison that the right-hand bend in the river was directing flows toward the properties in the early 2000s (red and orange) when the major erosion events occurred. This bend has continued to push further downstream, moving approximately 100m north, past the properties (green). It was also noted that the average channel width has increased from roughly 100m in 2006 to 180m in 2019 and present. This widening allows for increased flood relief within the banks; however, it also provides easier meandering of the active channel within the gravel bar and floodplain area.

Current channel alignment does not present a direct threat to the properties as the main channel has migrated to the far side of the channel, leaving the home on the inside of the bend. This portion of the channel appears more stable than downstream reaches, due to the tall banks of the west. Vegetation has also begun re-establishing on the gravel bars in front of the properties. It was noted that bank instability further upstream may result in unknown impacts on future channel alignment.

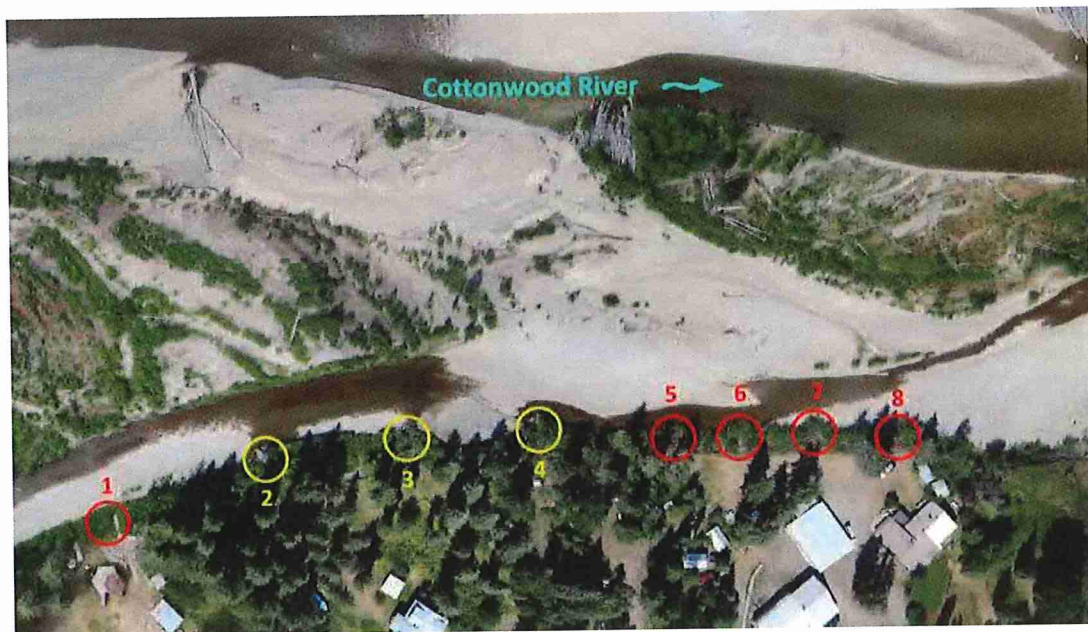
Figure 3: Spur Locations Overview

As described in the CRD summary notes, the bank protection works prescribed in the Streamworks 2010 report were constructed in 2012. This consisted of Streamworks Option A, a collection of rock and large woody debris (LWD) spurs to deflect flows off of the riverbank in front of the remaining properties. The works identified during the DWB site visit are labelled on Figure 3, with rock spurs in Red and LWD spurs in Yellow. In total 8 structures were identified; 5 rock spurs and 3 LWD spurs. This is less than the prescribed 12 spurs from the Streamworks plan. Confirmation that only 8 structures were constructed was provided by residents during the inspection.

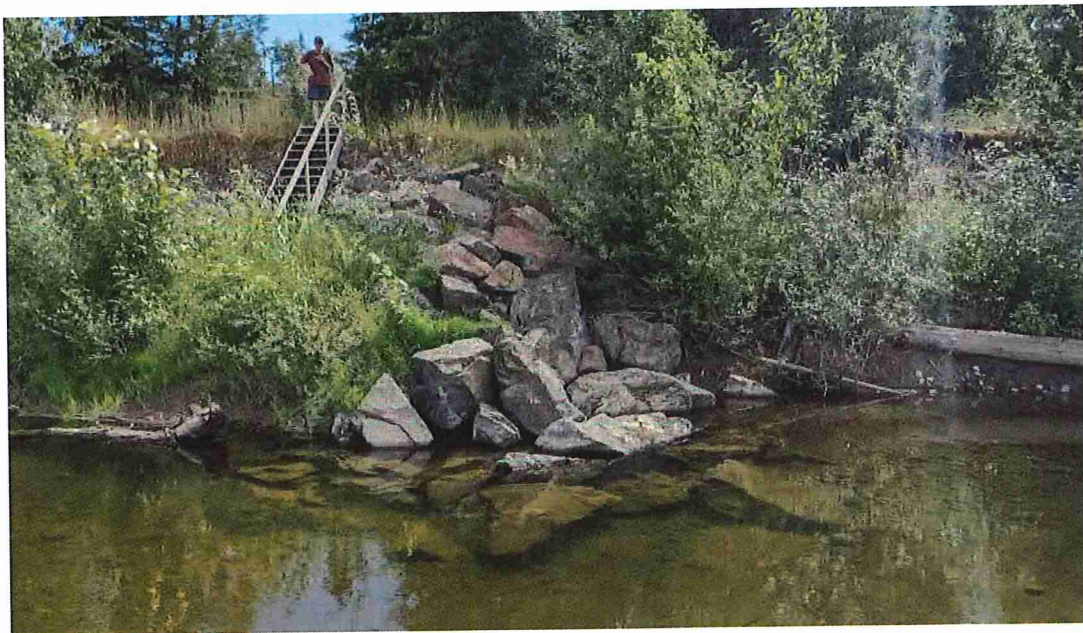
Figure 4: Rock Spur #5

All rock spurs are similar in size, being roughly 2m tall, 5m wide and extending 6 to 7m from top of bank to toe of spur. This matched prescription dimensions. Spurs appear to be constructed of class 250kg riprap with larger key boulders. Riprap appears to be appropriately graded with good embedment and bank key-in. An example of the typical spur is shown in Figure 4, with additional photos in Appendix A. It should be noted that rock spur #1 was difficult to locate and identify due to heavy vegetation and conduction of the staircase. It is not believed that this has compromised the integrity of the spur.

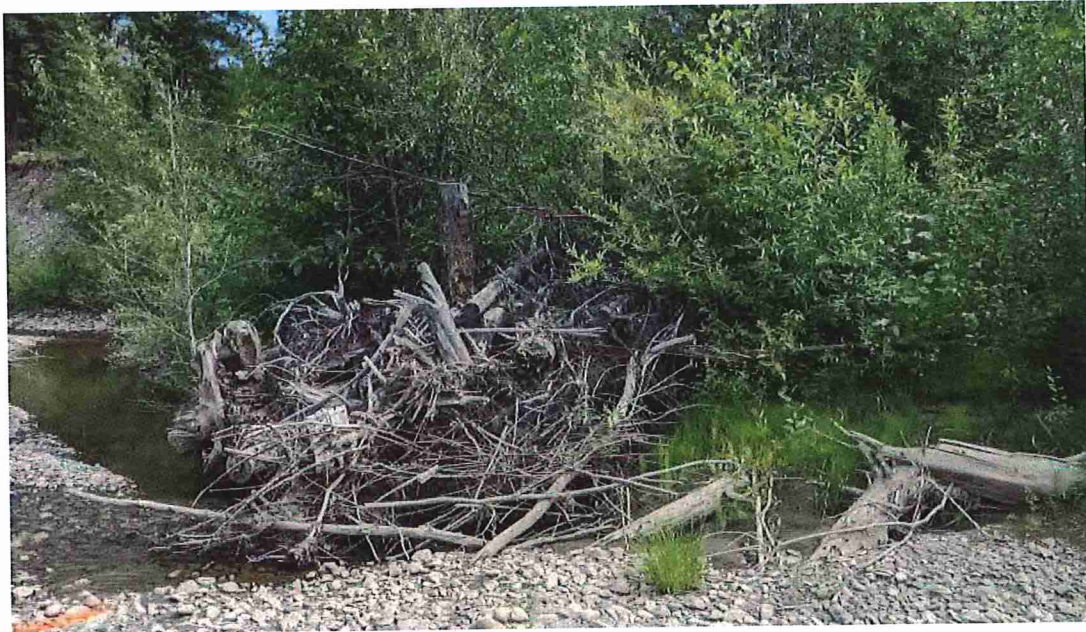
Figure 5: LWD Spur #3

Large Woody Debris spurs were also constructed (Figure 5), with additional LWD placed along the bank. This debris has been anchored to a core of riprap using bolts and chains. Visible chains are in good condition, with minimal surface rust. Chain connections to the rock anchors were not observed as they were buried in the channel bottom sedimentation. LWD spurs are similar in size to the rock spurs, with additional branch length. Both the rock and LWD spurs are vegetating well.

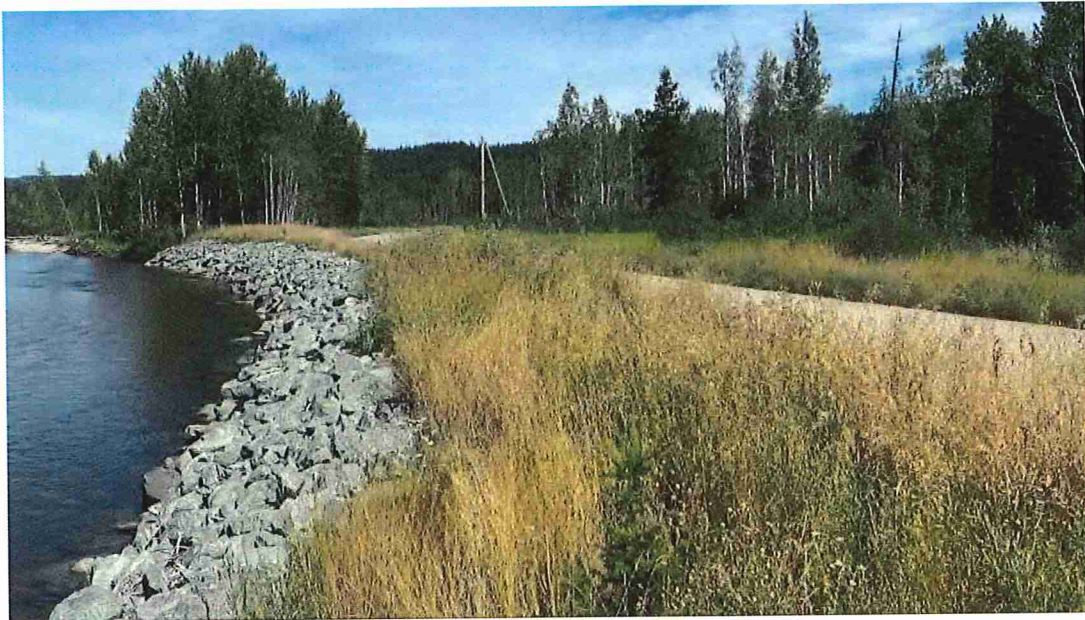
Figure 6: Riprap Armouring (Looking North)

The rock armouring is holding up well and is currently at a stable slope between 1.5:1 and 2:1 as shown in Figure 6. Approximately 6m of grassy shoulder remains at the narrowest point between the rock armouring and the edge of road. Minor erosion with overhanging grasses and small cavities in the native soils was observed above the top of the riprap, however, vegetation suggests this is a minor or slow event.

Downstream roadside armouring also appears to be in good condition, with stable slopes, fair gradation, and no identified holes. Minor scour was identified at the top of the riprap; however, it does not appear to be migrating or undermining the armouring at this time. Armouring may be considered by MOTI for road protection if erosion continues.

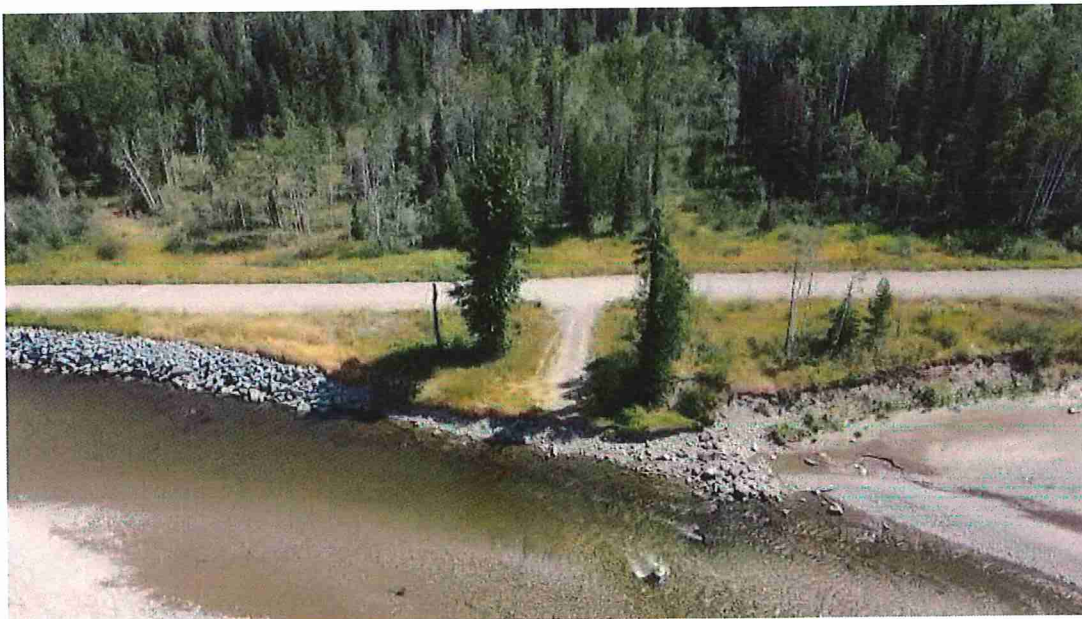
Figure 7: Unarmoured Bank (Looking East)

River banks upstream from this riprap armouring have been subject to scour. A spur of large boulders is present where the east-most side channel re-enters the current main channel, with approximately 15 to 20m remaining between the bank and the road shoulder. At the time of the visit and as presented with the channel morphology above, this Cottonwood River's main channel currently impacts this unarmoured section of the bank between the spurs and downstream armouring, shown in Figure 7.

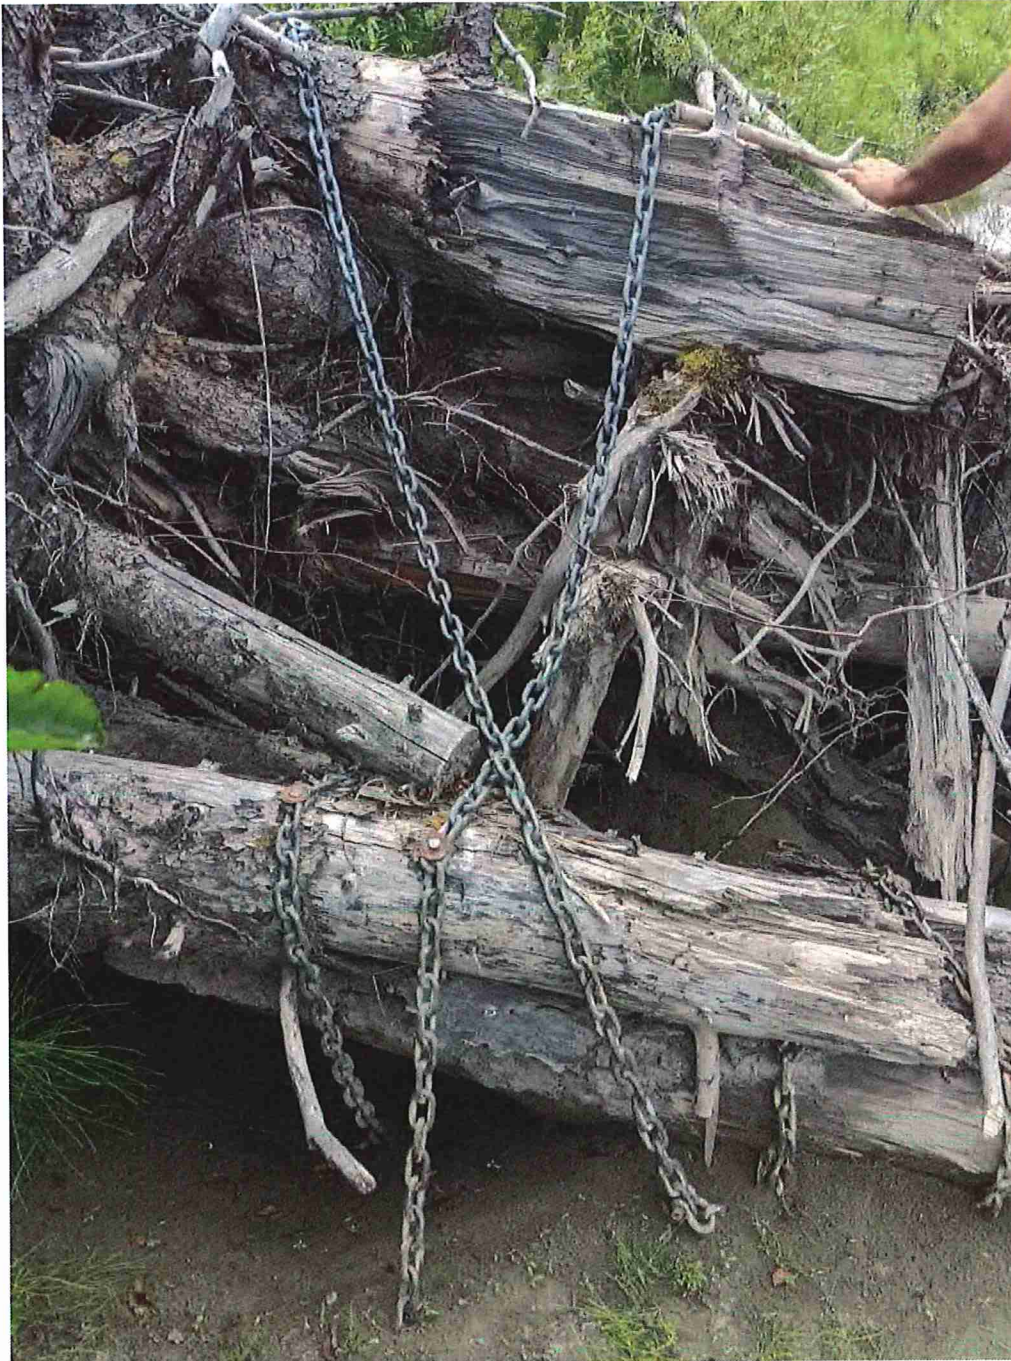
Anchor Chains on LWD (Spur #2)

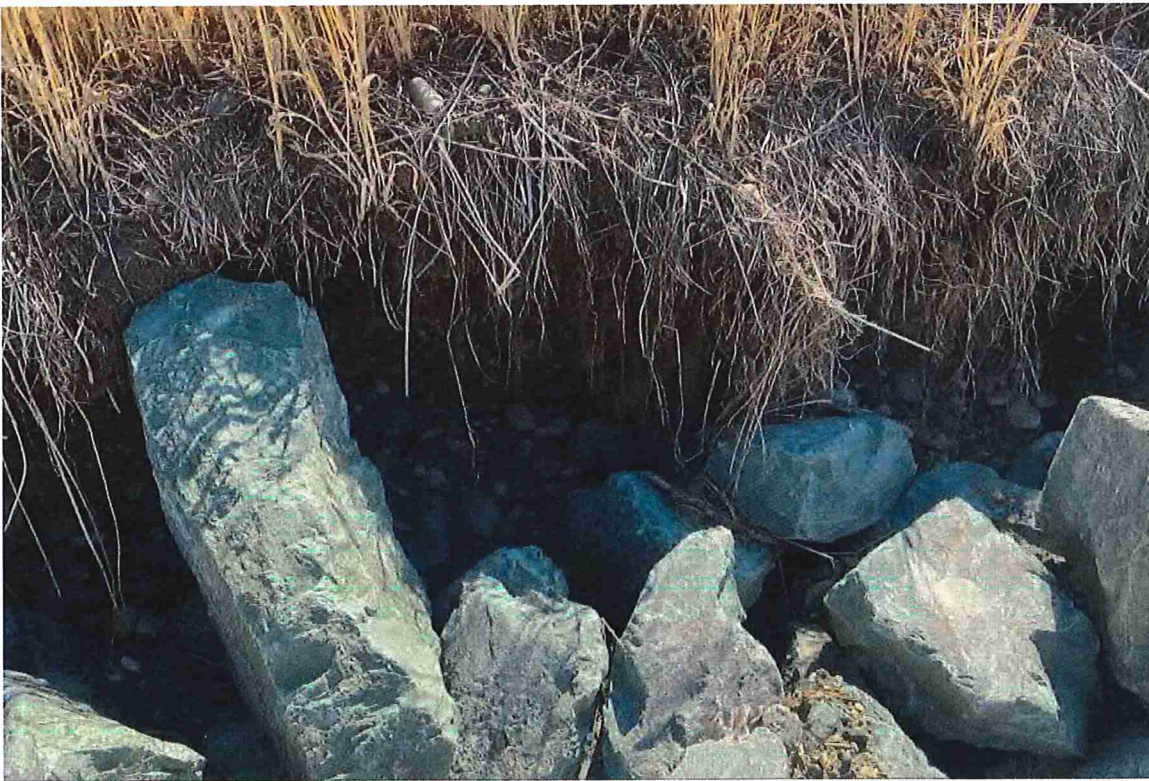
Quesnel-Hixon Road Protection – Riprap Top Scour
