WWAL Project: 22-072-01PG

Cariboo Regional District  
Suite D, 180 North Third Ave.  
Williams Lake, B.C.  
V2G 2A4

**Re: Groundwater Feasibility Assessment for the Tatla Lake Community, Tatla Lake, BC**

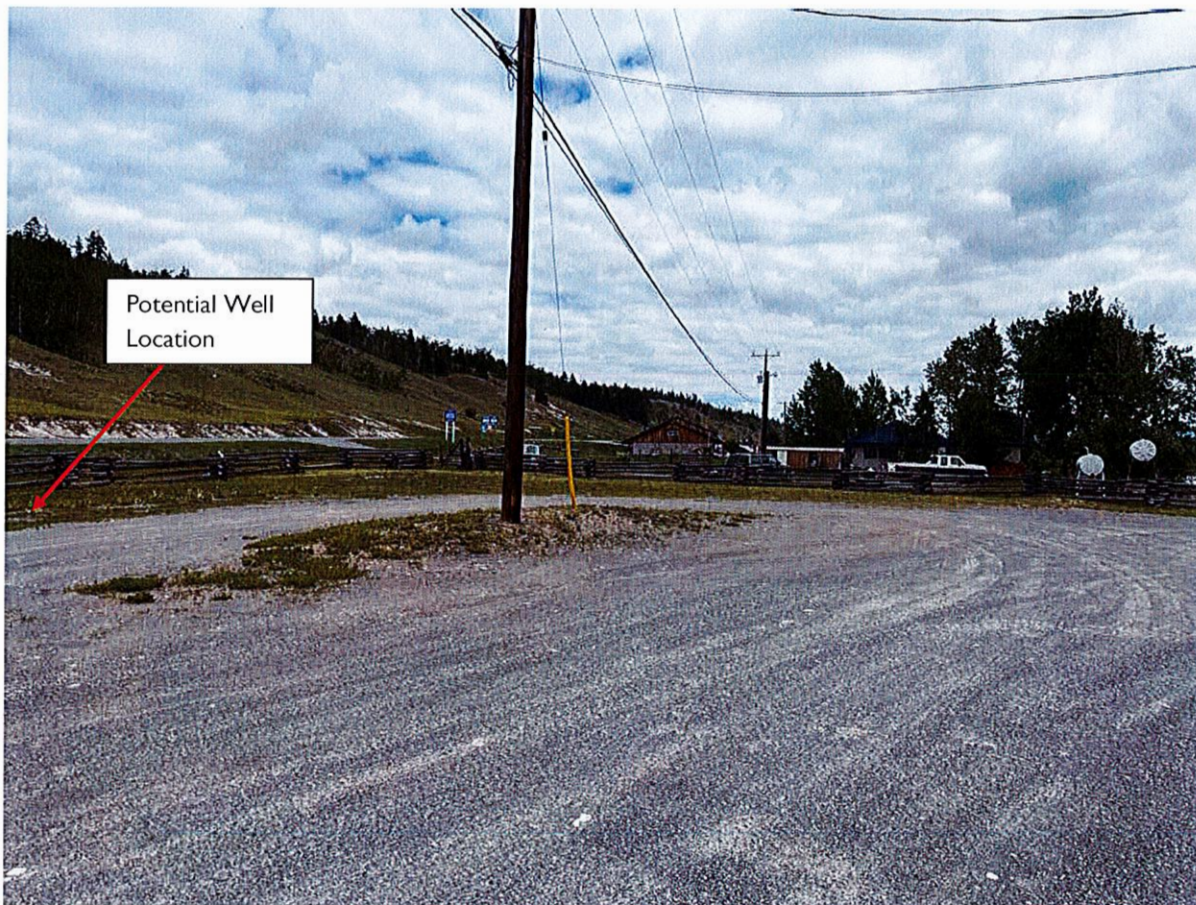
Photo 2: North parking lot of Tatla Lake community hall with potential well location near existing sign.

If a well is desired to be drilled within the community area, available space would be present at the community hall (Kirby, 2022). While onsite, the location of nearby septic systems and any other sources of contamination were discussed and a well location on the north side of the community hall property (near the existing sign) would meet all applicable setbacks (Photo 2).

The Community Hall location has the advantage of available power supply and the property is reportedly available for use (Kirby, 2022). With respect to well construction, a cemented surface seal and other controls will be necessary to accommodate a flowing artesian well resulting in a more expensive drilling program.
