Planning Application Referral Package

Application Type: Agricultural Land Reserve

File Number: 3015-20/C20240020

Proposal: It is proposed to use the property for the placement of fill from the Bastin Hill Landslide as well as provide aggregate for Ministry of Transportation and Infrastructure projects. Topsoil will be stockpiled and property will be recontoured to be conducive to agriculture upon completion. Fill activities are proposed for two years and extraction activities proposed for 50 years.

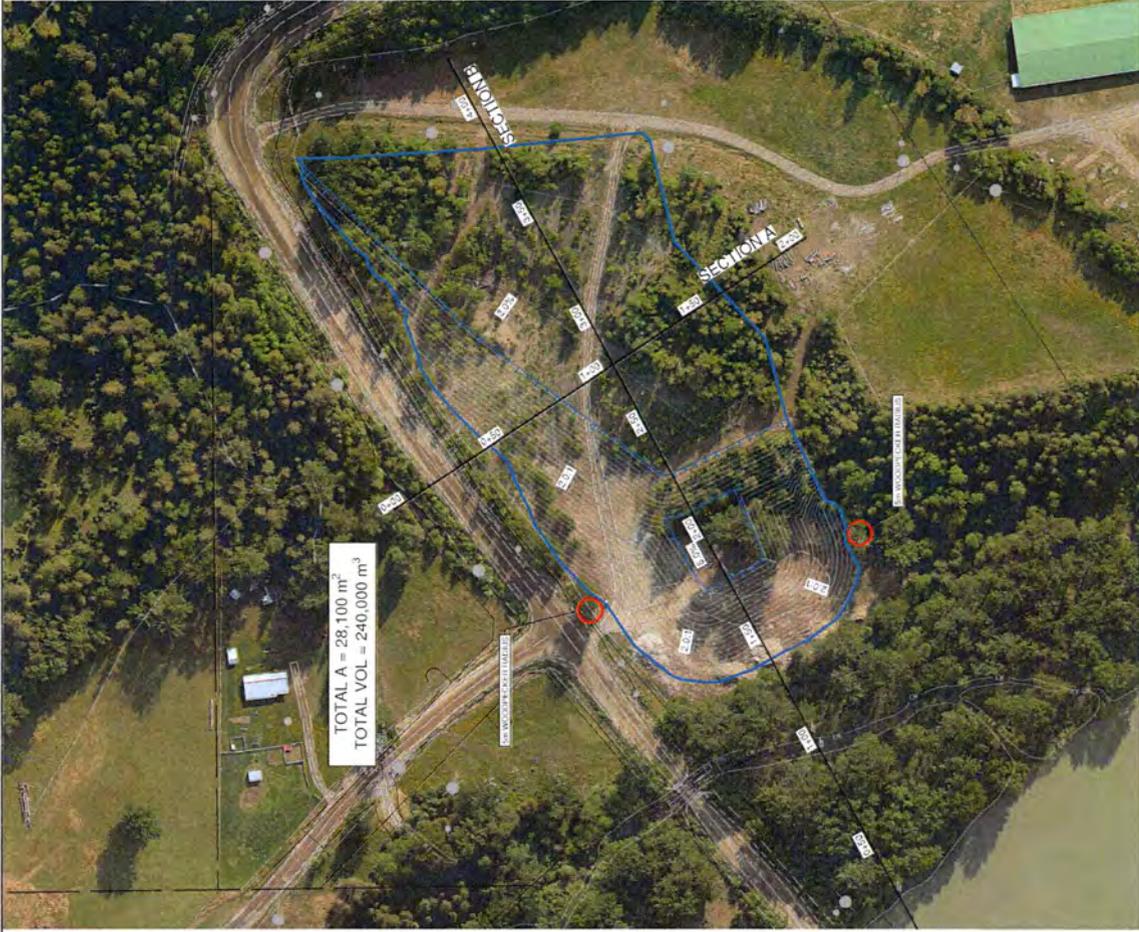
PLAN
 0m 10m 50m
 1:10,000
 BASTIN HILL STOCKPILE
 5m RADIUS AROUND WOODPECKER TREES

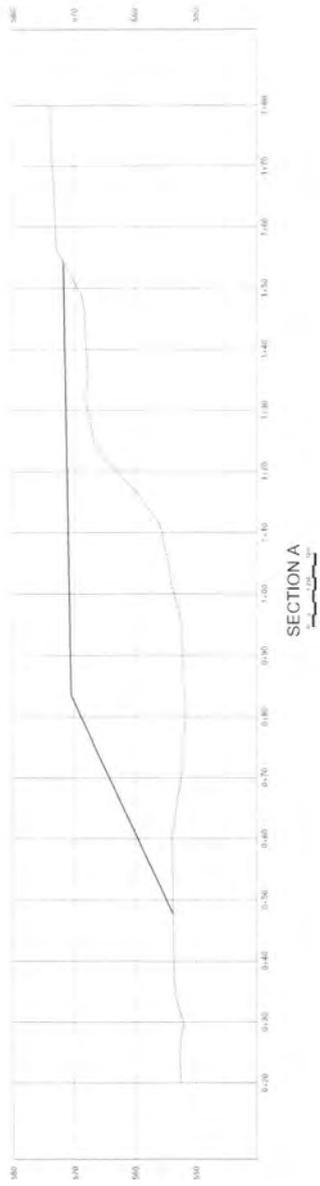
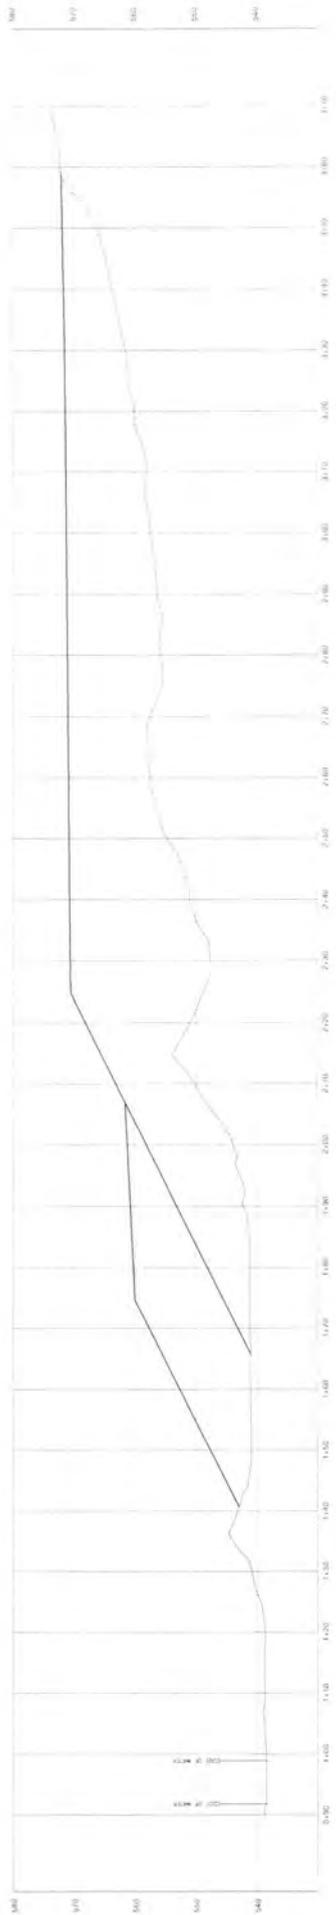
BASTIN HILL STOCKPILL
5m RADII AROUND WOODPECKER TREES

BASTIN PIT CROSS-SECTION A to A'

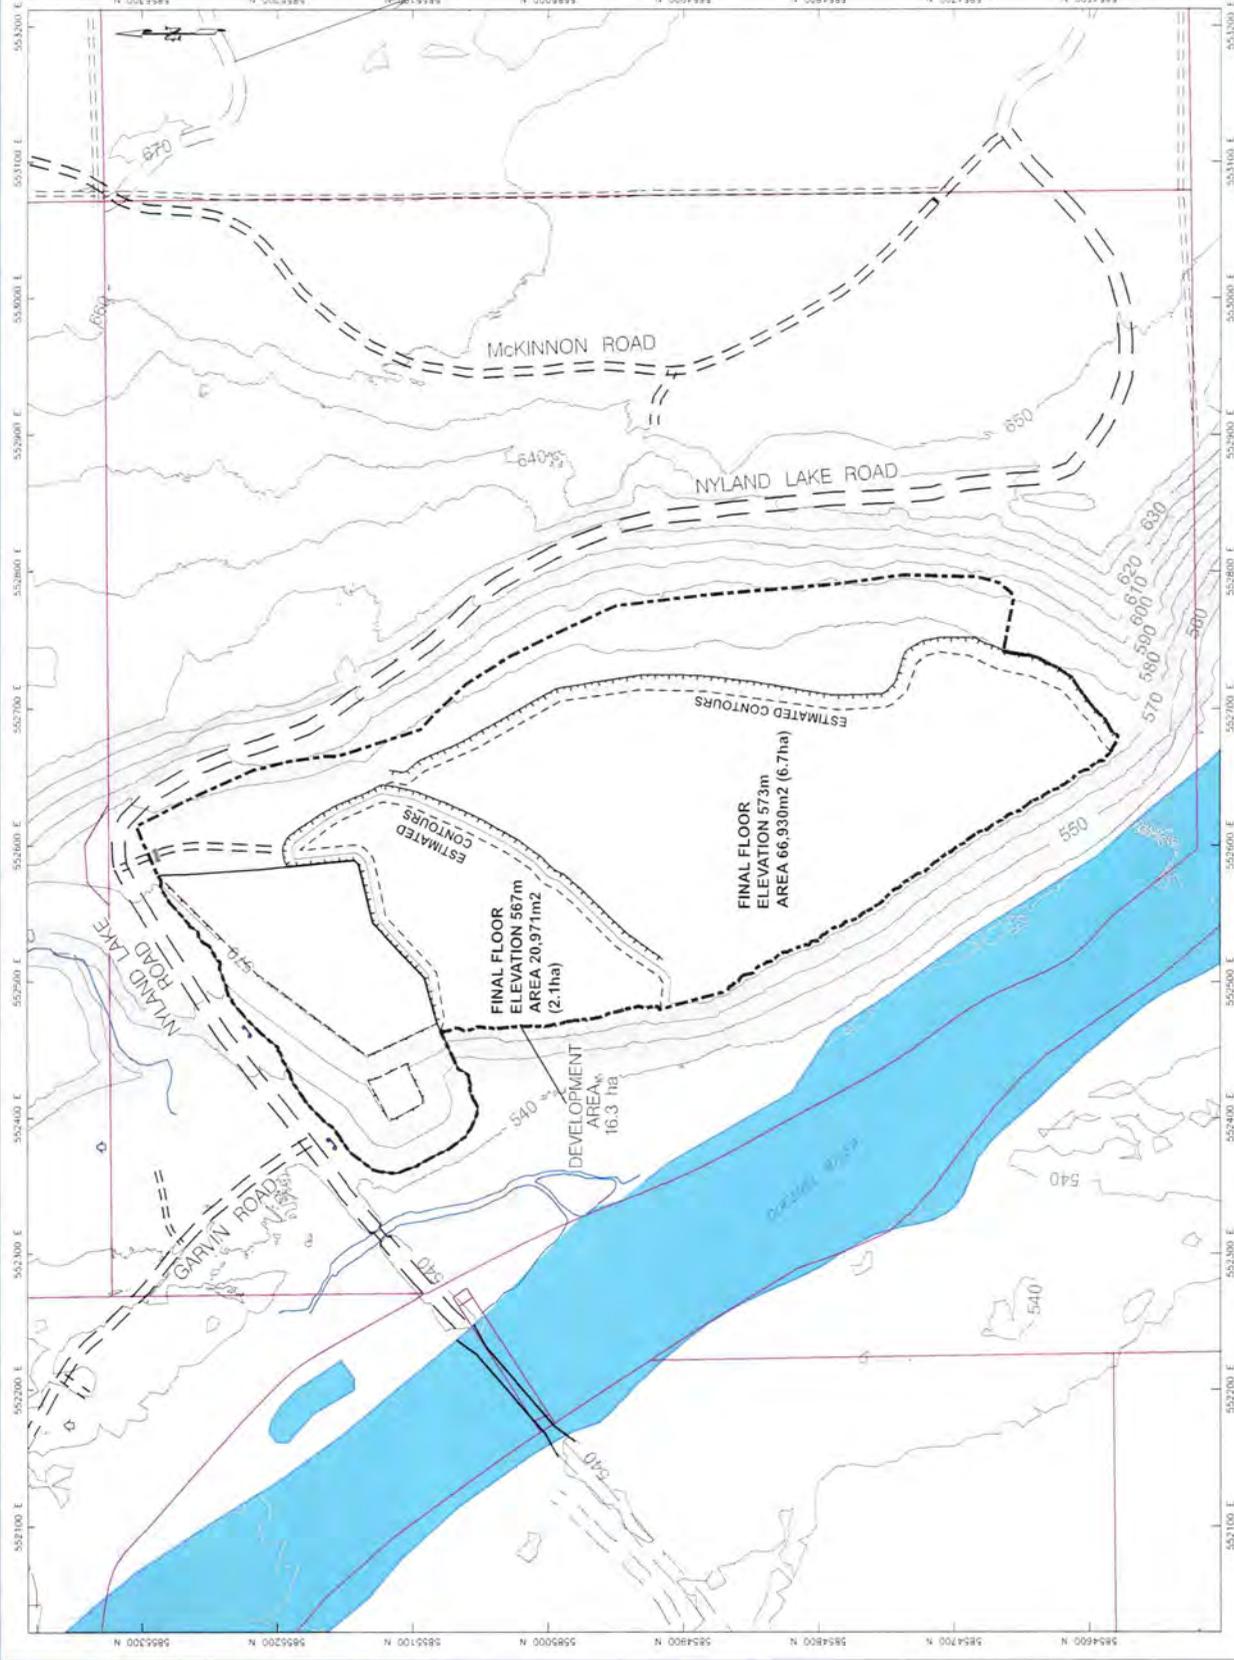
BASTIN PIT #1471
PIT RECLAMATION PLAN
 FILE NO. Bastin_ReclamationPlan

PIT RECLAMATION NOTES:

- Pit development and reclamation must be carried out in accordance with the Soil and Reclamation Code for British Columbia, the Inter-Soil Standards Specifications for Highway Construction, and the Aggregate Operations Best Management Practices Handbook for BC and the Statute Engineering Basin Pit Agricultural Soils Assessment September 2023 report.
- All permanent reclaimed slopes must be re-sloped to no steeper than 2H:1V.
- Scarify all compacted surfaces and replace topsoil over all previously stripped areas to the depths prior to pit development.
- Seed reclaimed area with an appropriate grass mixture for the geographic area.
- Site will be inspected periodically to ensure successful regeneration of grass.
- No dumping of debris or petroleum products is permitted. The pit must be left in a clean and safe condition.

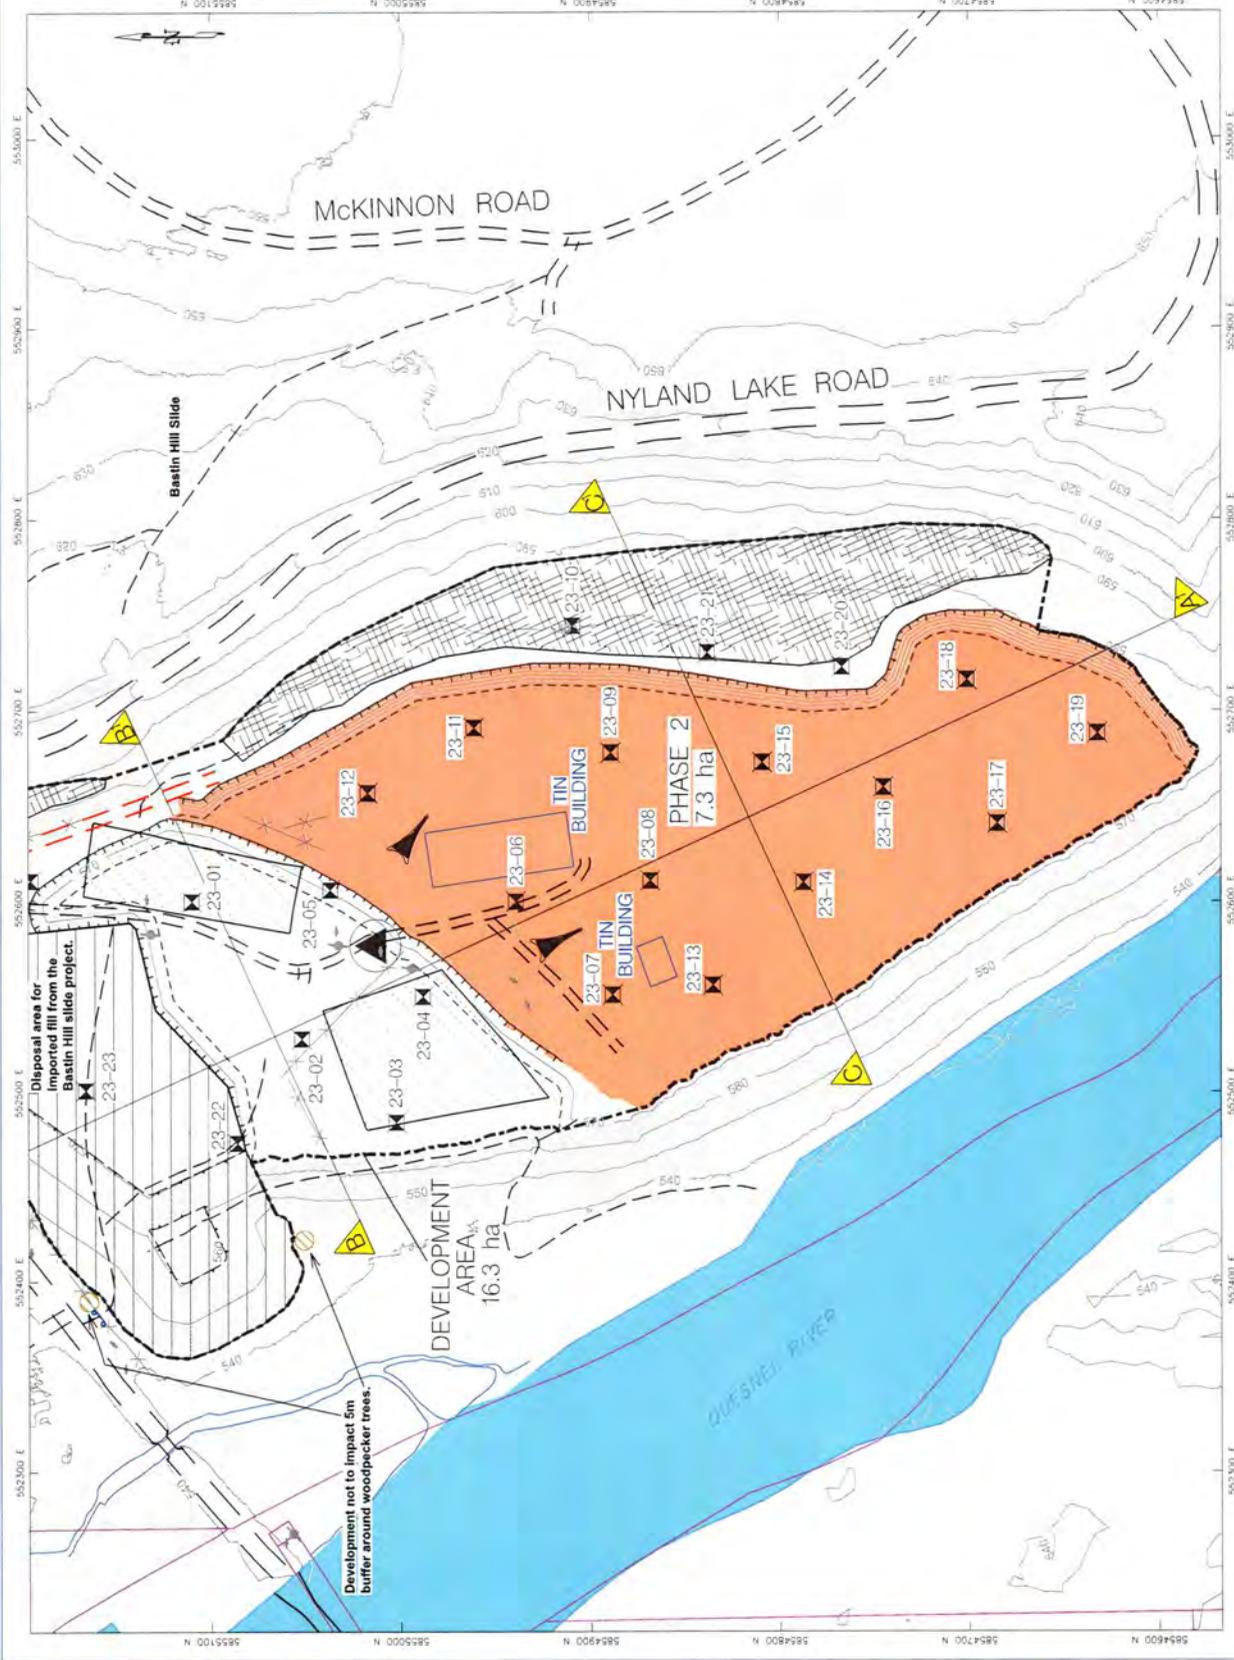
BASTIN PIT #1471
 PIT DEVELOPMENT PLAN-Phase 2
 FILE NO. Bastin_PDP_P12

3. PIT excavations must not take place to a depth a minimum of 1.5H to 2H, where H is the maximum height of the existing and stripped areas.
4. When the contractor discontinues operations in the pit, all working pit faces and stockpiles must be trimmed to 1:1H to 1V slope. Working pit faces must be reshaped with native granular materials. All other permanent slopes must be reshaped to no steeper than 2H:1V.

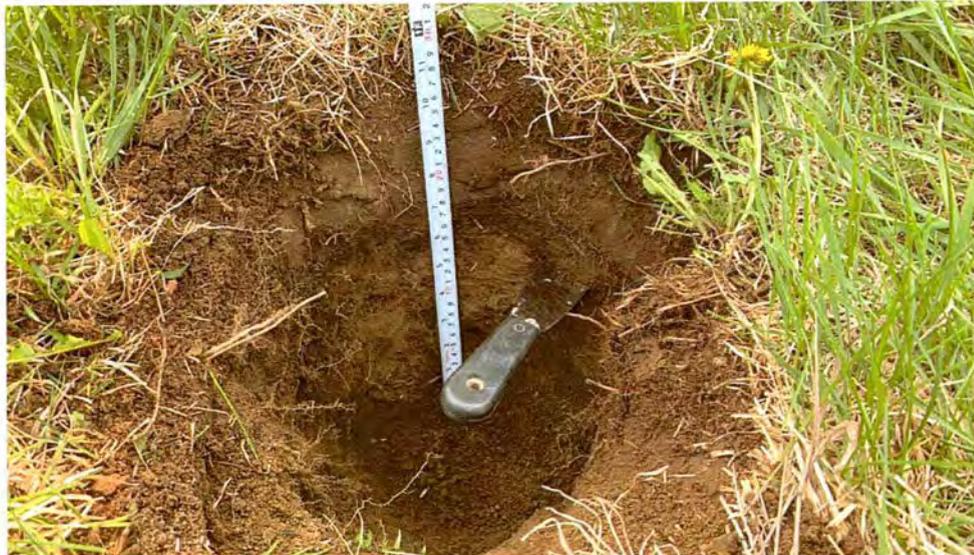
Photo A.2 Site BP001 – Pit – Saxton SMU: Orthic Sombric Brunisol with 15 cm topsoil (Ap) depth

The dominant soils observed under agricultural use (pasture) within the proposed Pit were categorized as Saxton (SXT), which are dominantly Orthic Eutric Brunisols developed on well-drained fluvial material. Saxton soils were observed to have a poor contrast between the topsoil and subsoil making it difficult to see the colour change between topsoil and upper subsoil. The range of topsoil thickness observed across the site was between 9 centimetres (cm) and 22 cm with the average of depth of 16 cm thickness.

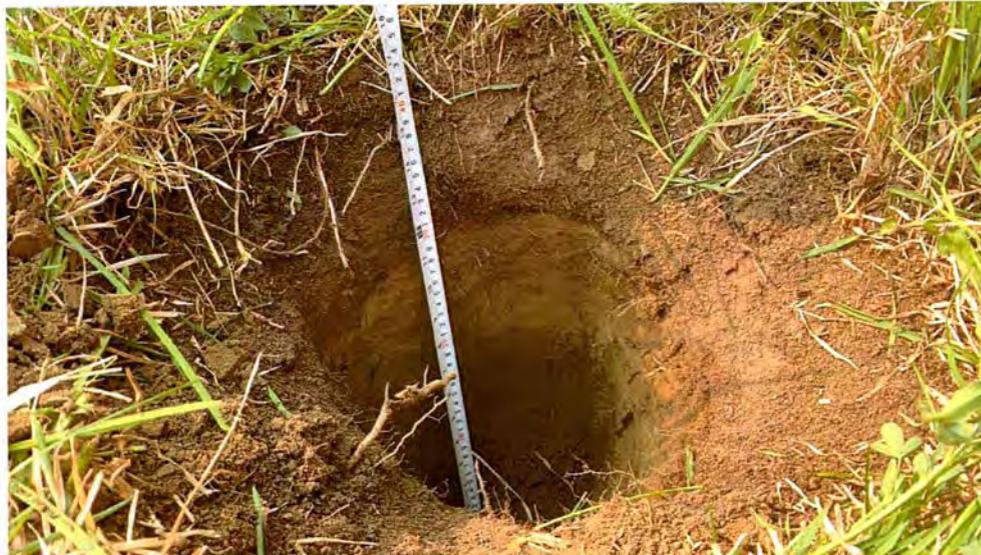
Photo A.4 Site BP002 – Pit – Bednesti SMU: Brunisolic Gray Luvisol with 15 cm topsoil (Ap) depth

Bednesti (BDT) soils are Brunisolic Gray Luvisols that are developed on fluvial veneers over glaciolacustrine parent material. The topsoil thickness was observed at 20 cm with a good colour change between the topsoil and subsoil. These soils can be salvaged to the colour change between the topsoil (LFH and A horizon or A horizon) and upper subsoil (B horizon).

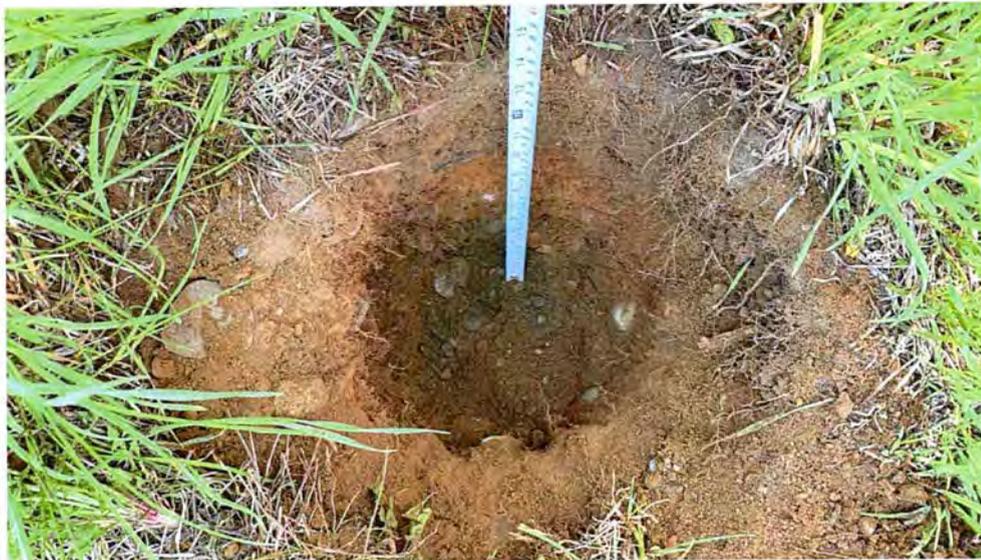
Photo A.6 **Site BP003 – Pit – Saxton SMU: Orthic Eutric Brunisol with 11 cm topsoil (Ap) depth**

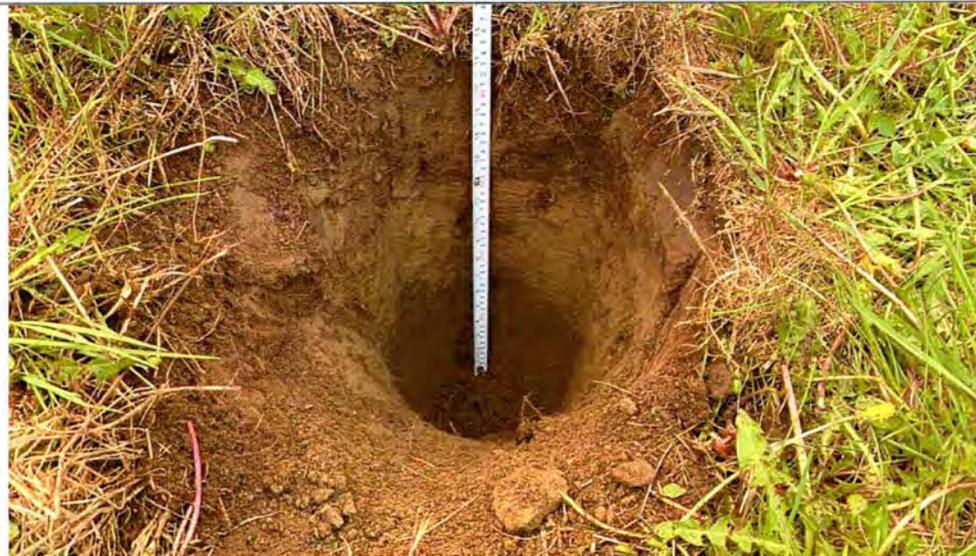
Photo A.8 Site BP004 – Pit – Saxton SMU Orthic Eutric Brunisol with 15 cm topsoil (Ap) depth

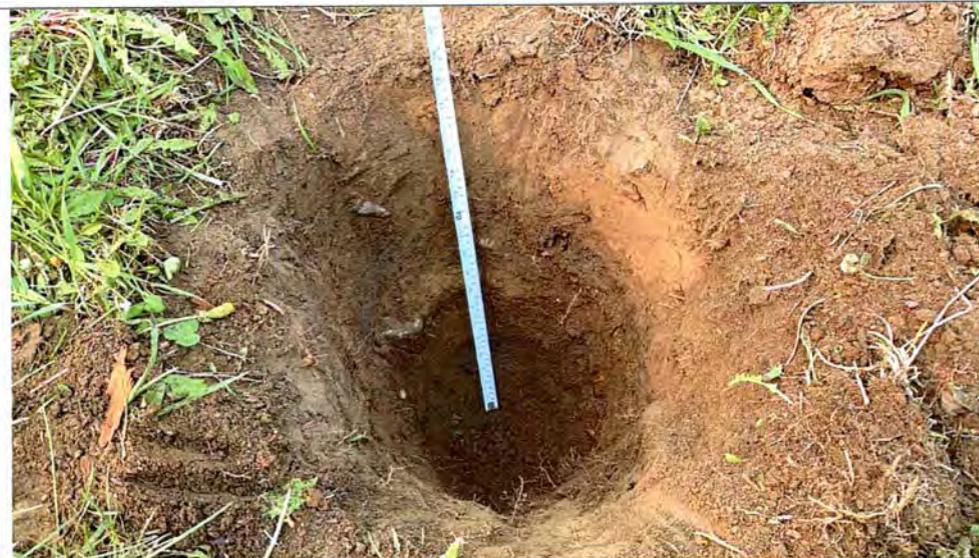
Photo A.10 Site BP005 – Pit – Saxton SMU Orthic Eutric Brunisol with 22 cm topsoil (Ap) depth

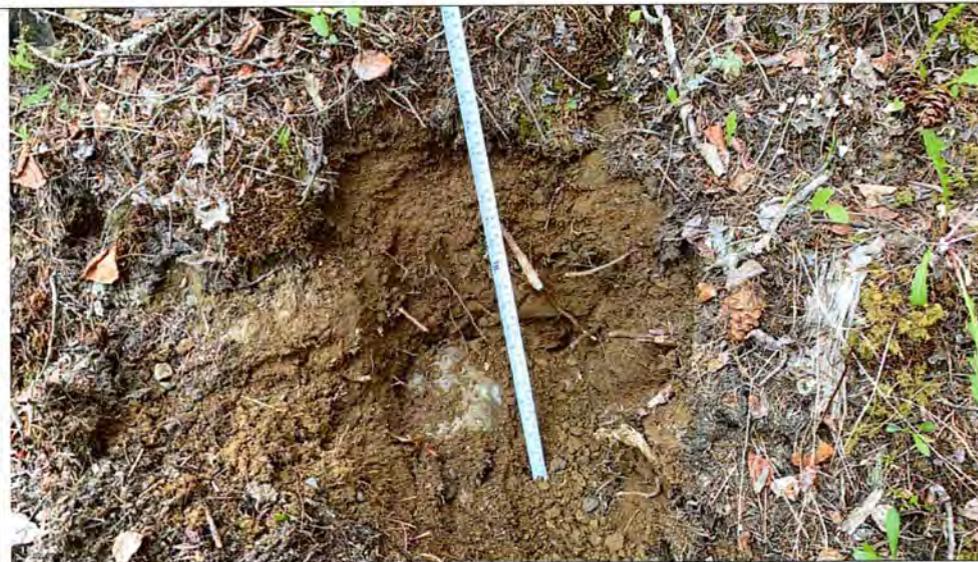
Photo A.12 Site BP006 – Pit – Misc. Regosol Orthic Regosol

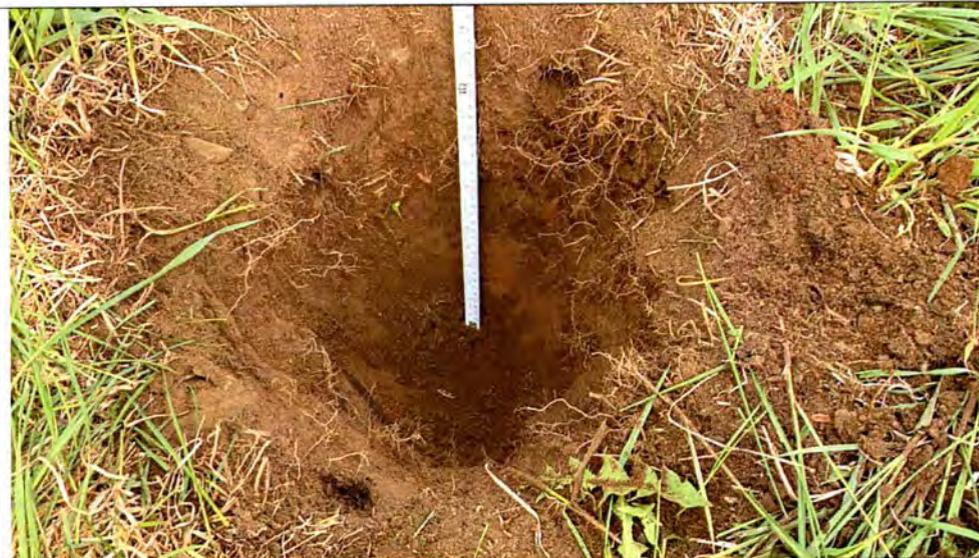
Photo A.14 Site BP007 – Pit – Saxton SMU Orthic Eutric Brunisol with 22 cm topsoil (Ap) depth

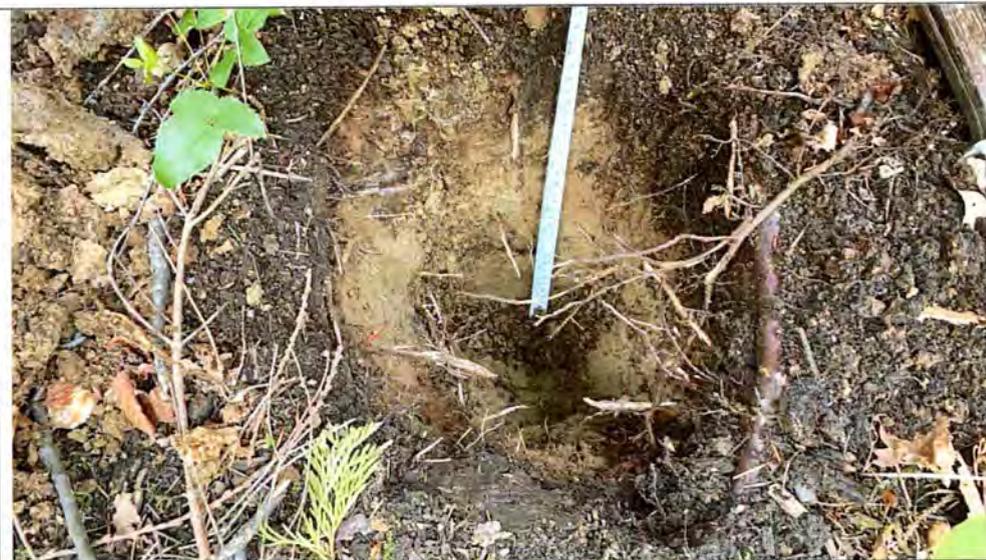
Photo A.16 Site BP008 – Pit – Beaverley Orthic Gray Luvisol with 30 cm topsoil (LFH +Ae) depth

Beaverley (BVY) soils are Orthic Gray Luvisols developed on moderately well drained glaciolacustrine parent material. The topsoil thickness was observed at 30 cm with a good colour change between the topsoil and subsoil. These soils can be salvaged to the colour change between the topsoil (LFH and A horizon or A horizon) and upper subsoil (B horizon).

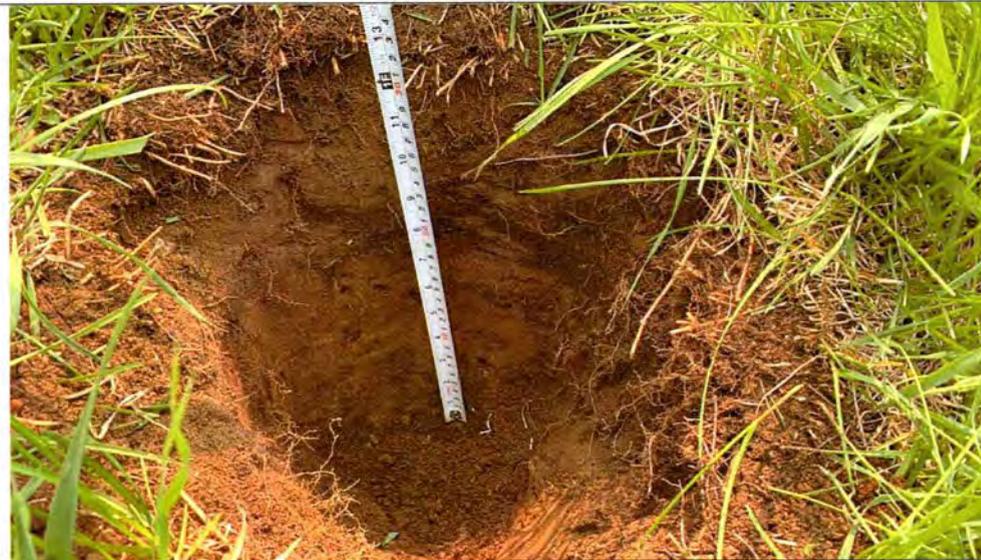
Photo A.18 Site BP009 – Pit - ZAL SMU with 15 cm topsoil (Ap) depth

The remaining soils mapped within the proposed Pit have been previously disturbed. Land surrounding the farmyard has been mapped as abandoned land (ZAL). It was observed that there is intermittent topsoil remaining in some disturbed areas and intact soil in these disturbed areas have properties of the SXT SMU. Areas with previous disturbance and no topsoil make up the remainder of the SMU and have been mapped as previous disturbance (ZDL). Photographs of soil inspection sites are provided in Appendix A.

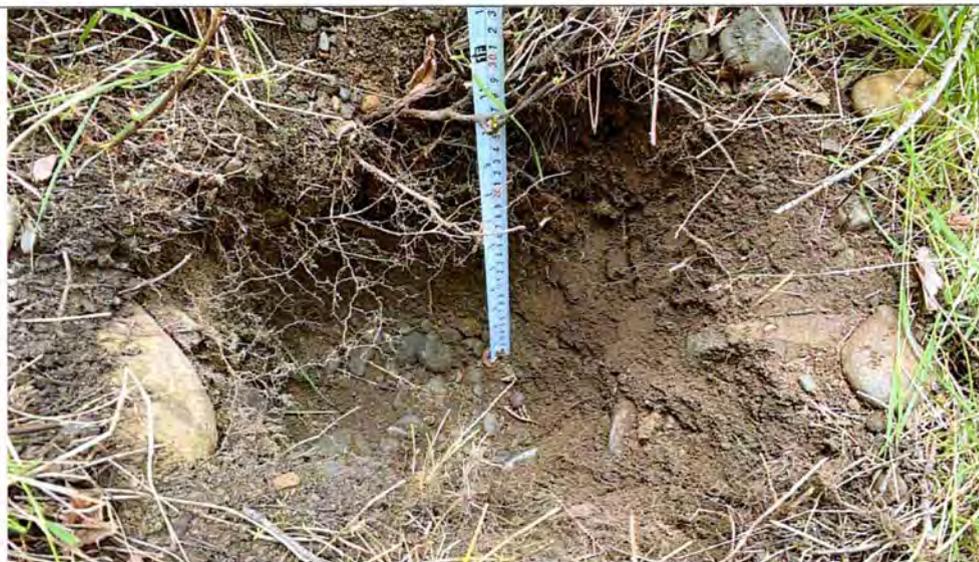
Photo A.20 Site BP010 – Pit – ZRG SMU Orthic Regosol

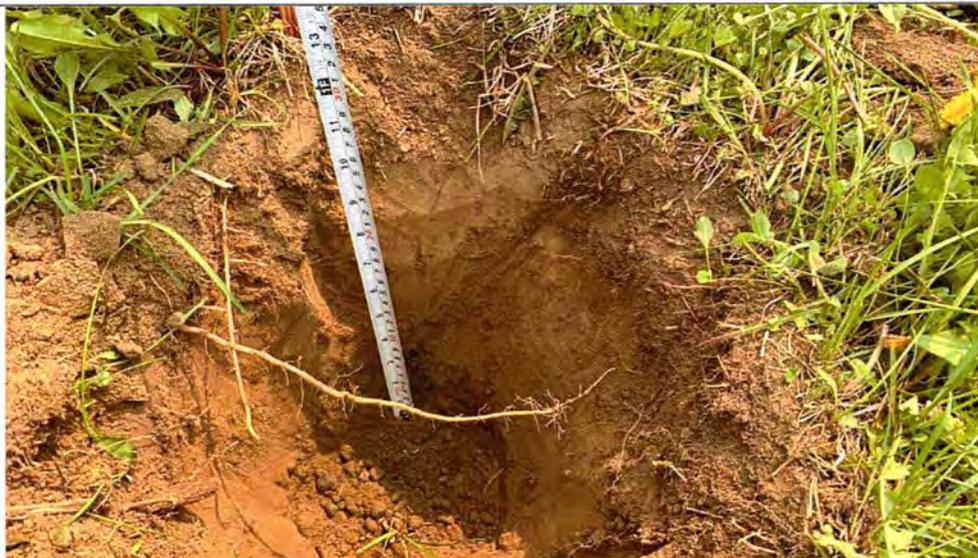
Photo A.22 Site BP011 – Pit – Saxton SMU Orthic Eutric Brunisol with 9 cm topsoil (Ap) depth

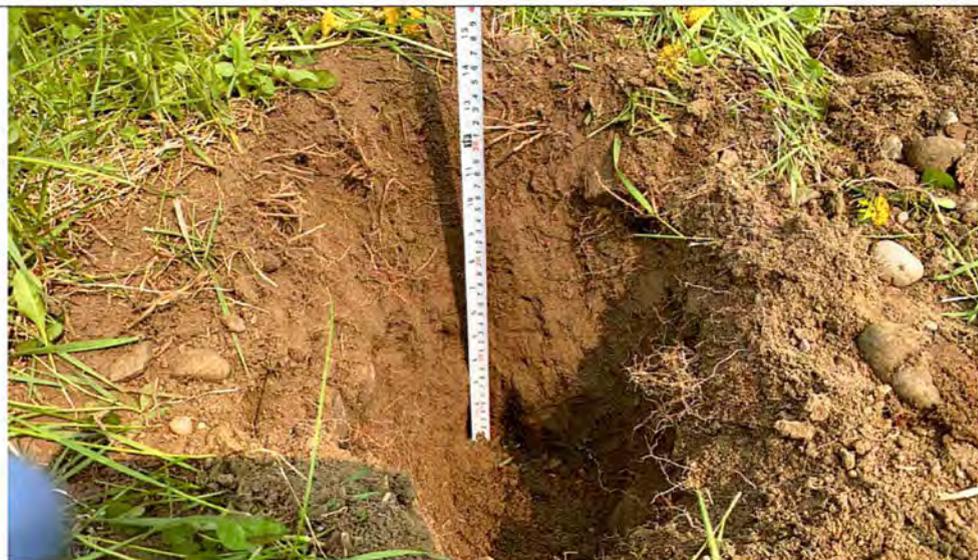
Photo A.24 Site BP012 – Pit – Saxton SMU Orthic Eutric Brunisol with 20 cm topsoil (ABp) depth

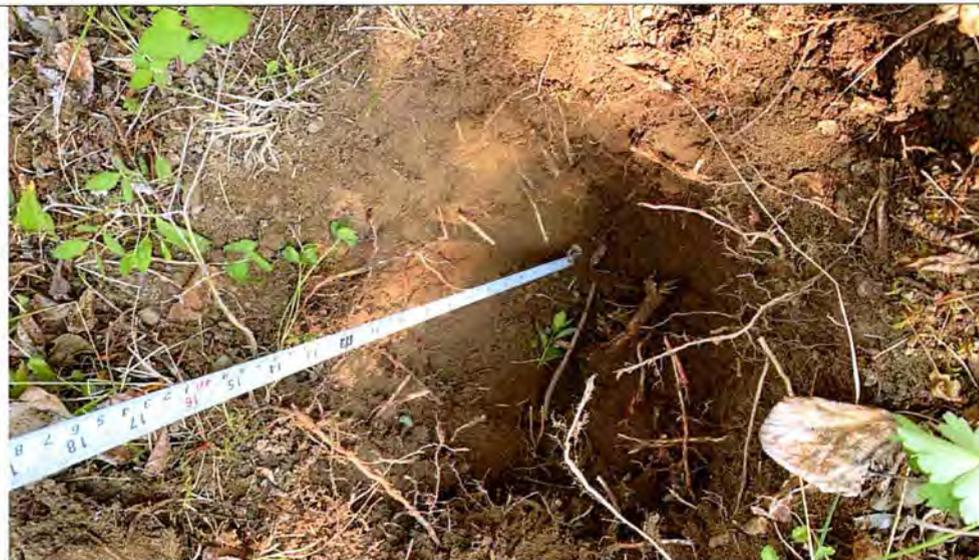
Photo A.26 Site BP013 – Pit – ZRG SMU Orthic Regosol

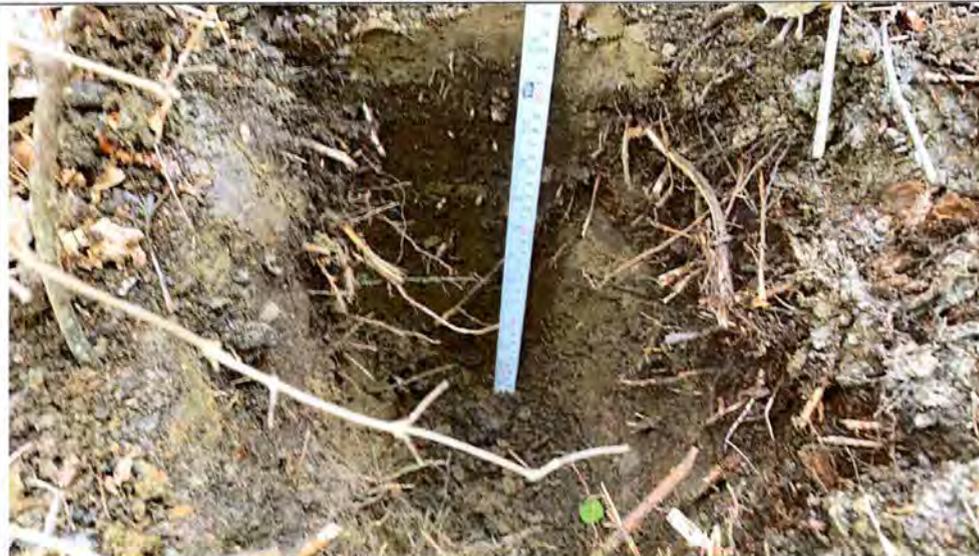
Photo A.28 Site BP014 – Pit – McGregor gleyed SMU – Gleyed Cumulic Regosol with 30 cm salvage depth

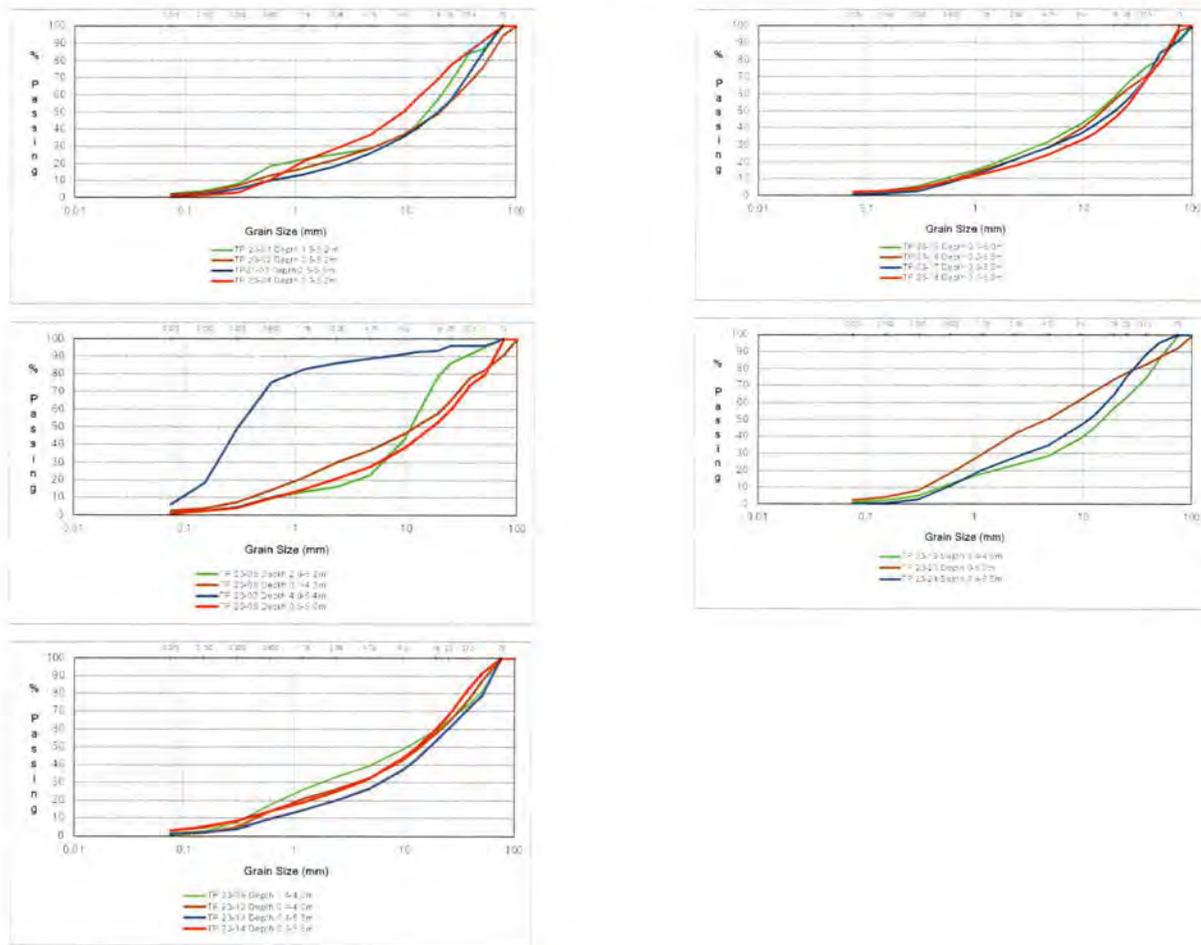
Pit Run Gradation Charts (Not corrected for oversize rock >75mm):

Sample Information		Percent Passing														
Test Pit	Depth	Pit Run Sieve Sizes (mm)														
		100	75	50	37.5	25	19	12.5	9.5	4.75	2.36	1.18	0.6	0.3	0.15	0.075
TP 23-01	Depth 1.5-5.2 m	100.0	100.0	86.5	84.2	67.3	56.2	42.4	37.2	29.0	25.7	22.5	18.9	8.2	4.2	2.6
TP 23-02	Depth 0.5-5.2m	100.0	94.0	76.1	67.7	55.9	48.5	41.4	37.2	29.0	22.6	17.3	13.2	7.5	3.4	1.9
TP 21-03	Depth 0.5-5.5m	100.0	100.0	84.9	72.9	56.6	49.3	40.4	35.4	26.0	18.9	13.4	10.1	5.4	2.3	1.3
TP 23-04	Depth 0.3-5.2m	100.0	100.0	91.4	85.4	77.2	68.7	57.9	50.3	36.9	29.3	21.3	10.9	3.2	1.8	1.3
TP 23-05	Depth 2.0-5.2m	100.0	100.0	95.3	91.8	86.2	77.9	56.9	43.0	22.9	16.4	13.5	10.3	4.5	2.4	1.5
TP 23-06	Depth 0.1-4.2m	100.0	91.1	82.4	78.2	65.5	57.8	50.8	46.4	37.2	30.2	21.3	14.5	7.5	3.9	2.6
TP 23-07	Depth 4.0-5.4m	100.0	100.0	96.0	96.0	96.0	93.4	92.5	91.3	88.7	86.3	82.6	75.3	49.5	18.5	6.2
TP 23-08	Depth 0.5-5.0m	100.0	100.0	79.8	74.0	59.9	52.6	43.7	38.4	27.7	21.1	14.6	9.6	4.2	2.1	1.1

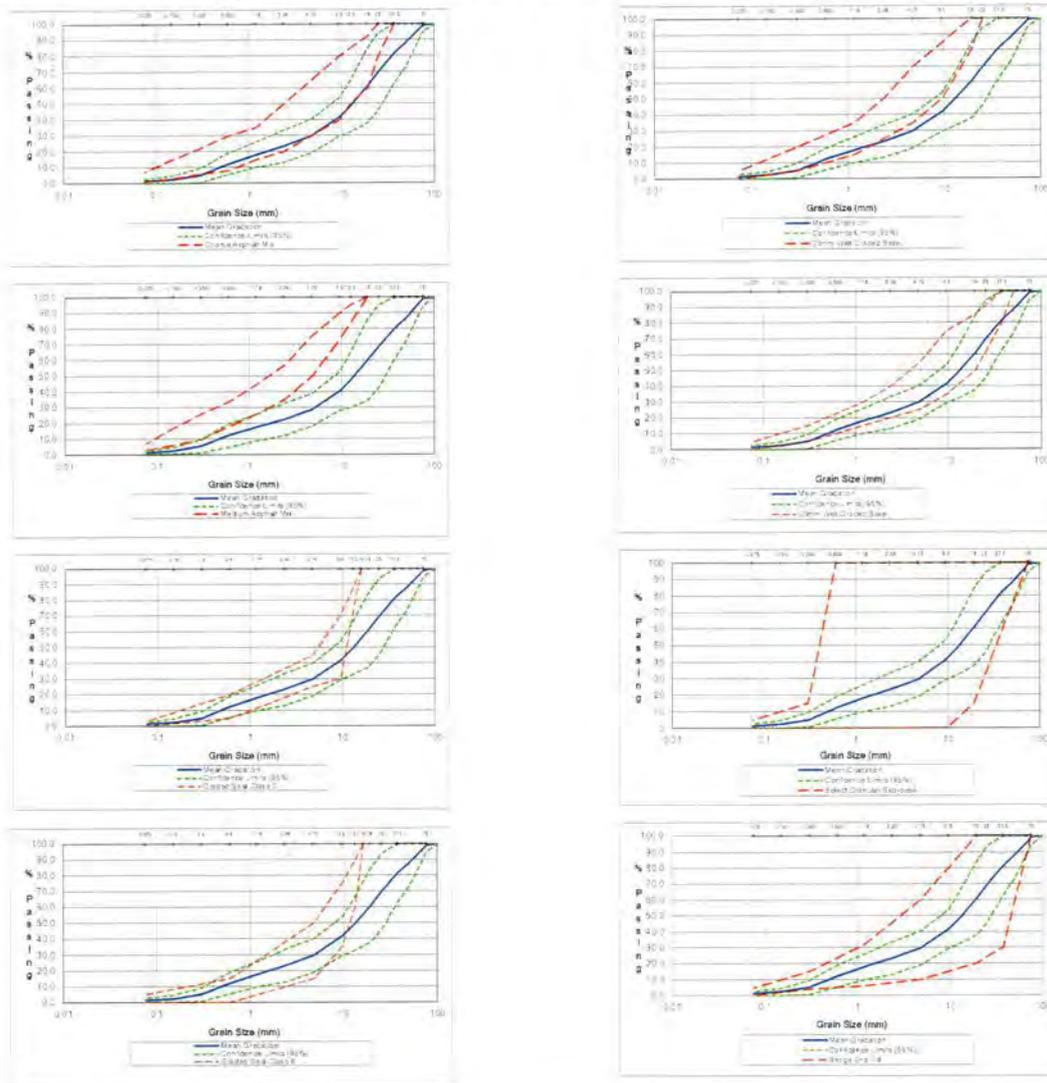
Phase 1 - Mean Gradations vs End Product Gradation Specifications:

Note: Mean gradations have not been adjusted to include oversize rock (>75mm)

- It will be necessary to scalp off rock during crushing in order to produce specification 25mm Well Graded Base.
- It may be possible to produce High Fines Surfacing Aggregate by adding a suitable mineral filler as well as rejecting rock during production.
- Laboratory testing indicates the absorption percentage is variable and should be reviewed when producing Graded Aggregate Seal products.

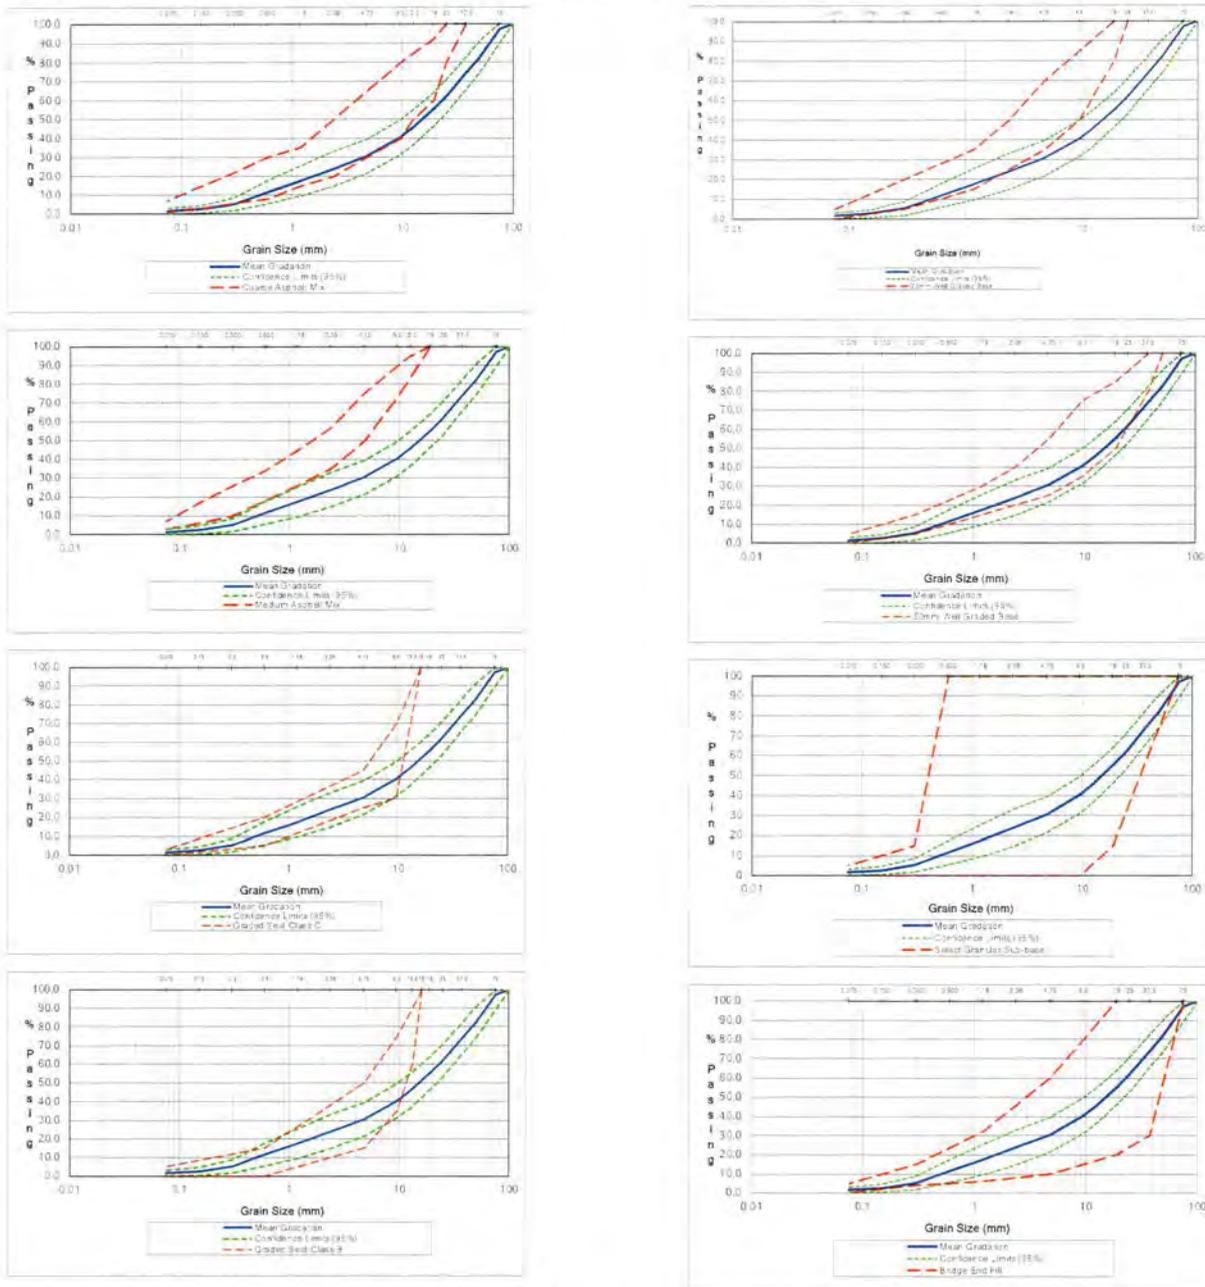
Phase 2 - Mean Gradations vs End Product Gradation Specifications:

- *It will be necessary to scalp off rock during crushing in order to produce specification 25mm Well Graded Base.*
- *It may be possible to produce High Fines Surfacing Aggregate by adding a suitable mineral filler as well as rejecting rock during production.*
- *Laboratory testing indicates the absorption percentage is variable and should be reviewed when producing Graded Aggregate Seal products.*

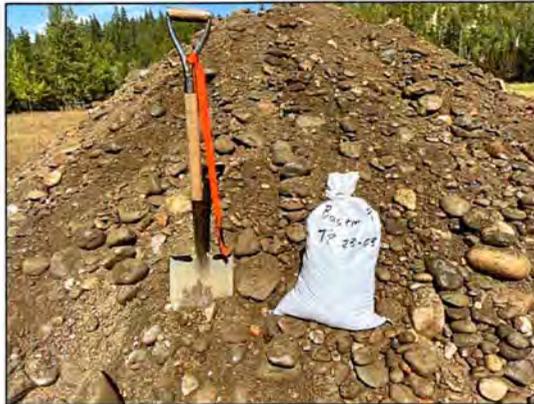
Test Pit 23-03 Spoil (Clean, coarse sand and gravel 0.5-5.2m)

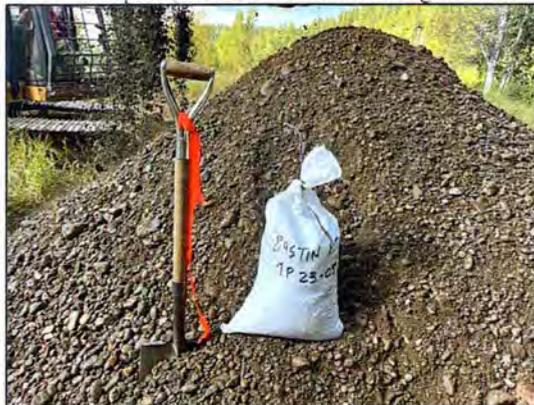
Test Pit 23-05 Spoil (Clean, coarse sand and gravel 2.0-4.5m)

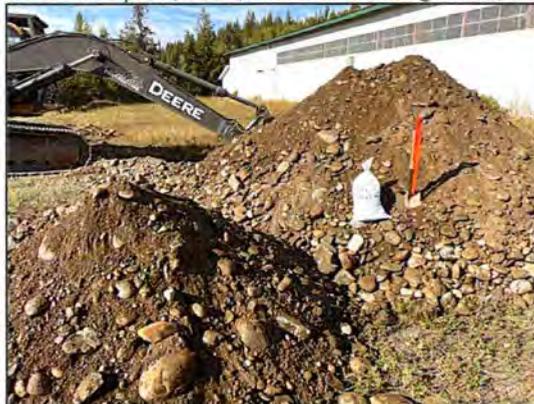
Test Pit 23-06 Spoil (Clean coarse sand and gravel 0.1-4.2m)

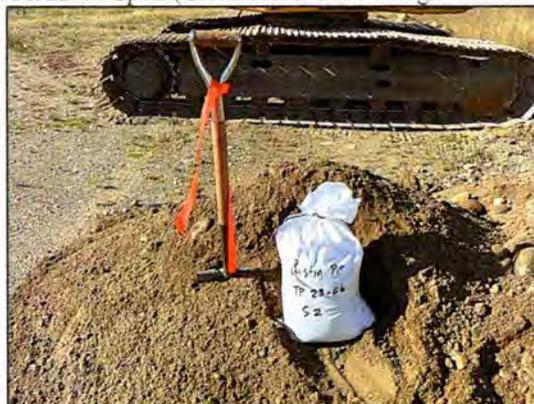
Test Pit 23-06 Spoil (High fines sand 4.2-5.4m)

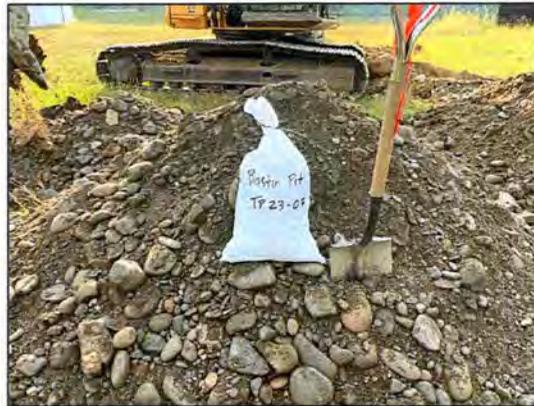
Test Pit 23-07 Spoil (Clean, coarse sand and gravel 0.5-5.0m)

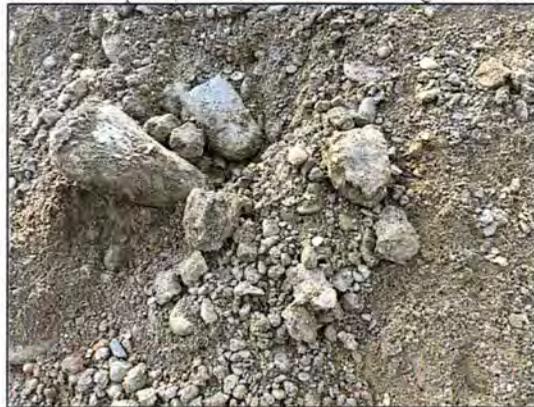
Test Pit 23-07 Spoil (Silt lumps mixed with gravel 5.0-6.0m)

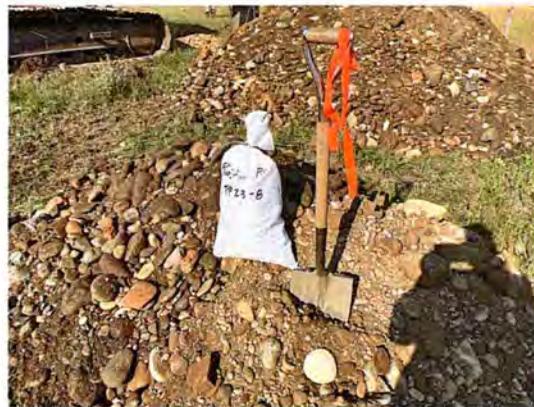
Test Pit 23-08 Spoil (Clean, coarse sand and gravel 0.1-4.6m)

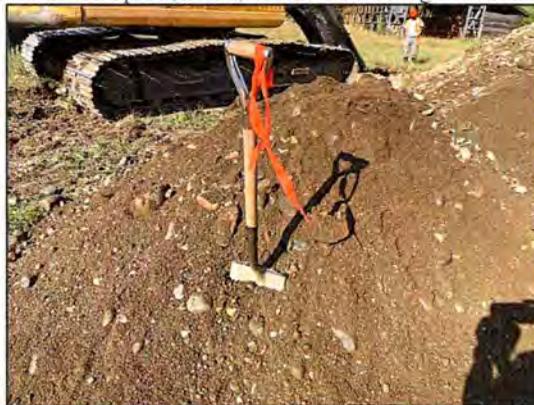
Test Pit 23-08 Spoil (Clean, gravelly sand 4.6-6.0m)

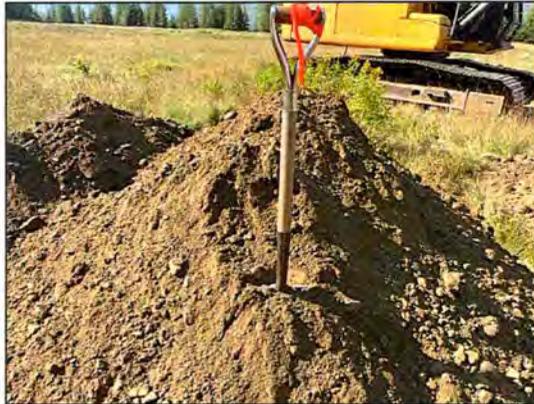
Test Pit 23-09 Spoil (High fines sand 2.8-6.0m)

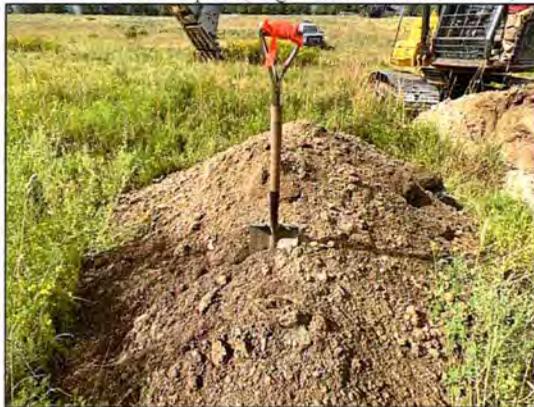
Test Pit 23-10 Spoil (High fines sand 0.1-5.0m)

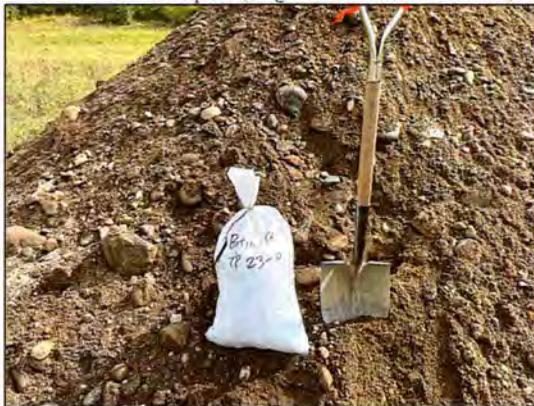
Test Pit 23-11 Spoil (Clean, coarse sand and gravel 1.4-4.0m)

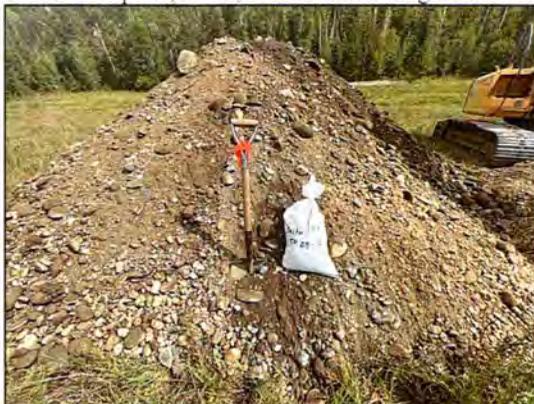
Test Pit 23-12 Spoil (Clean, coarse sand and gravel 0.4-4.0m)

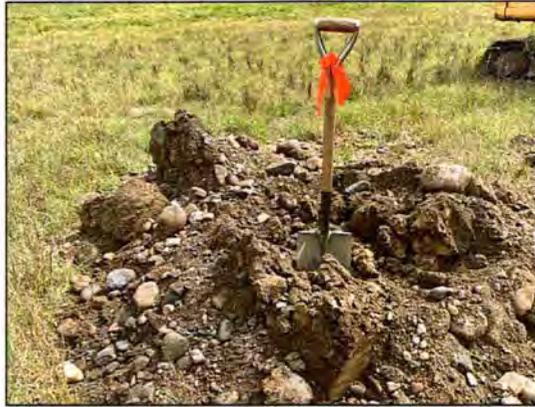
Test Pit 23-12 Spoil (Clay mixed with gravel 4.0-5.5m)

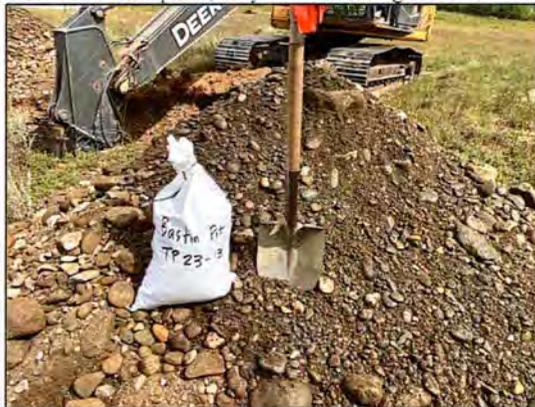
Test Pit 23-13 Spoil (Clean, coarse sand and gravel 0.1-5.5m)

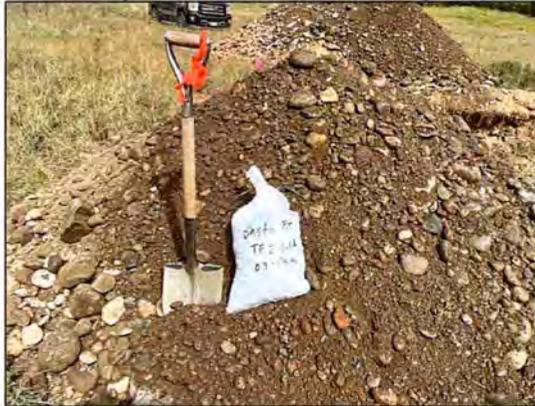
Test Pit 23-14 Spoil (Clean, coarse sand and gravel 0.3-5.6m)
