Planning Application Referral Package

Application Type: Agricultural Land Reserve

File Number: 3015-20/C20240020

Proposal: It is proposed to use the property for the placement of fill from the Bastin Hill Landslide as well as provide aggregate for Ministry of Transportation and Infrastructure projects. Topsoil will be stockpiled and property will be recontoured to be conducive to agriculture upon completion. Fill activities are proposed for two years and extraction activities proposed for 50 years.

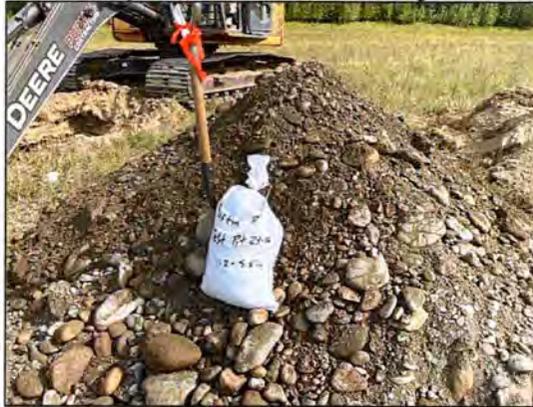
Test Pit 23-16 Spoil (Clean, coarse sand and gravel 0.2-5.5m)

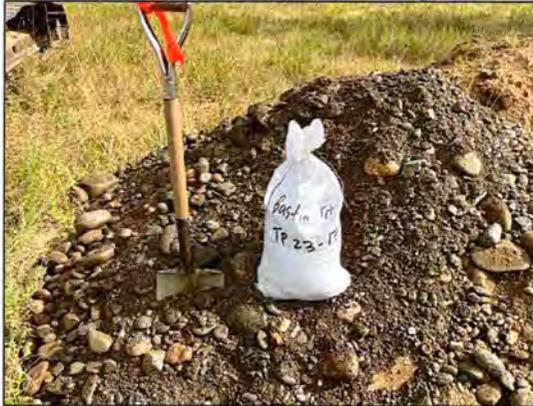
Test Pit 23-17 Spoil (Clean, coarse sand and gravel 0.2-5.5m)

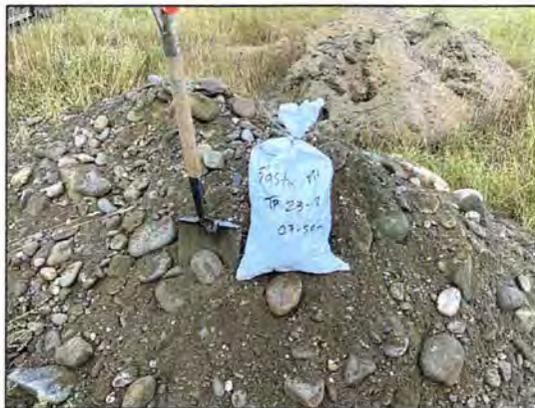
Test Pit 23-18 Spoil (Clean, coarse sand and gravel 0.7-5.0m)

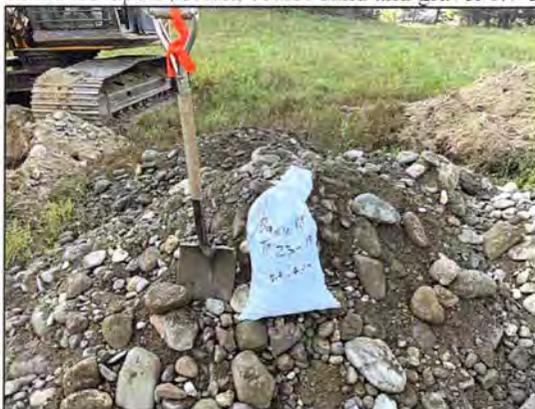
Test Pit 23-19 Spoil (Clean, coarse sand and gravel 0.4-5.0m)

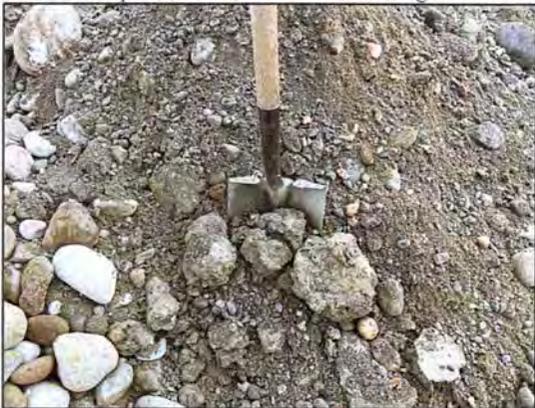
Test Pit 23-19 Spoil (Silt and clay mixed with gravel 5.0-5.5m)

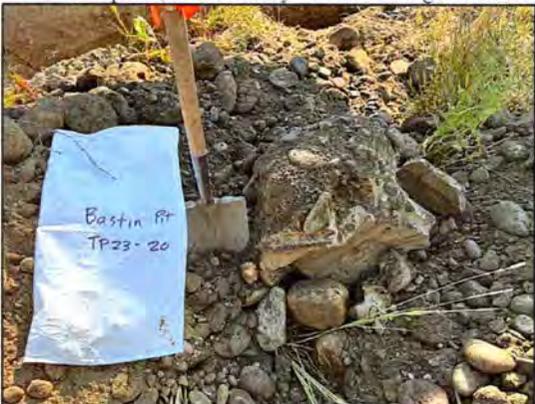
Test Pit 23-20 Spoil (Sand and gravel mixed with large clay lumps 1.2-5.5m)

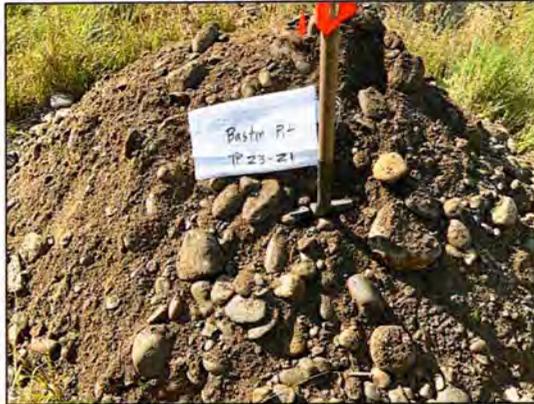
Test Pit 23-21 Spoil (Clean, coarse sand and gravel 2.8-5.5m)

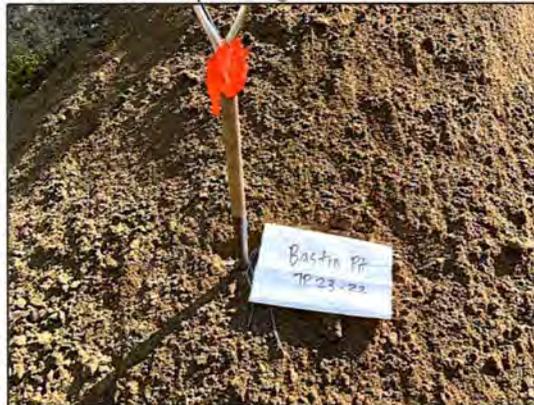
Test Pit 23-22 Spoil (High fines sand 1.8-6.0m)

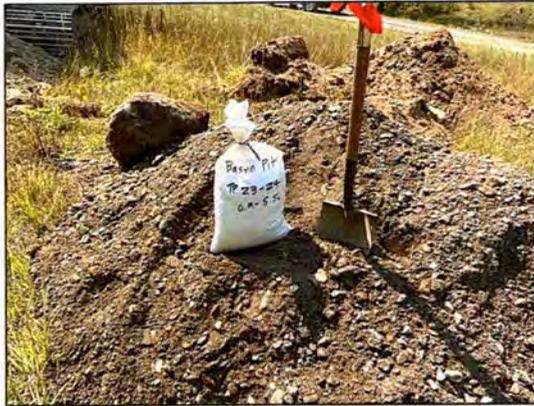
Test Pit 23-24 Spoil (Clean, coarse sand and gravel 0.9-5.5m)

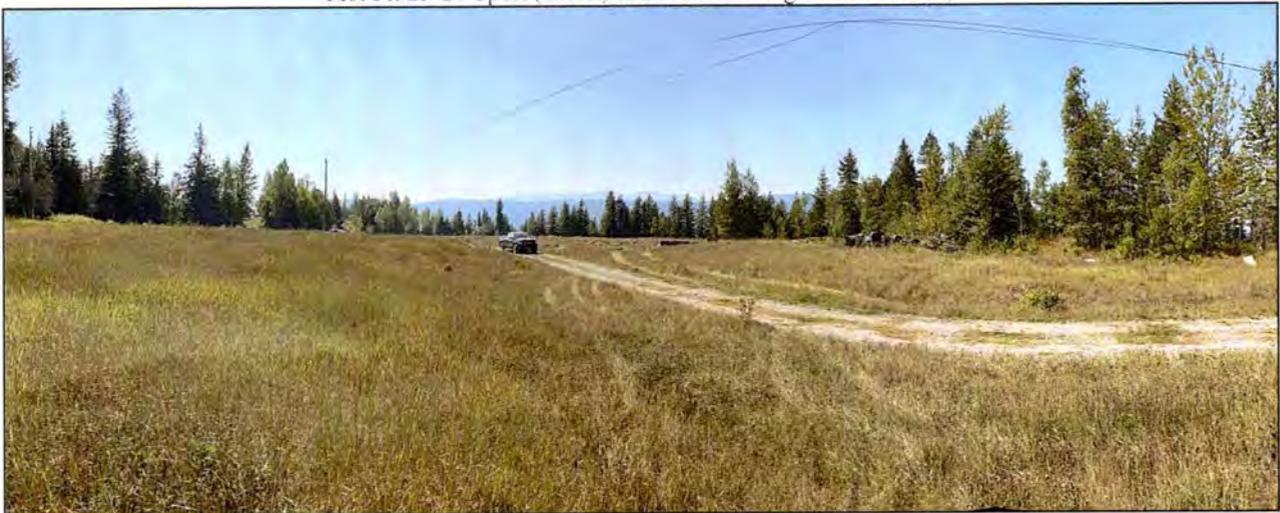
Phase 1 Mining Area (lower terrace looking south)

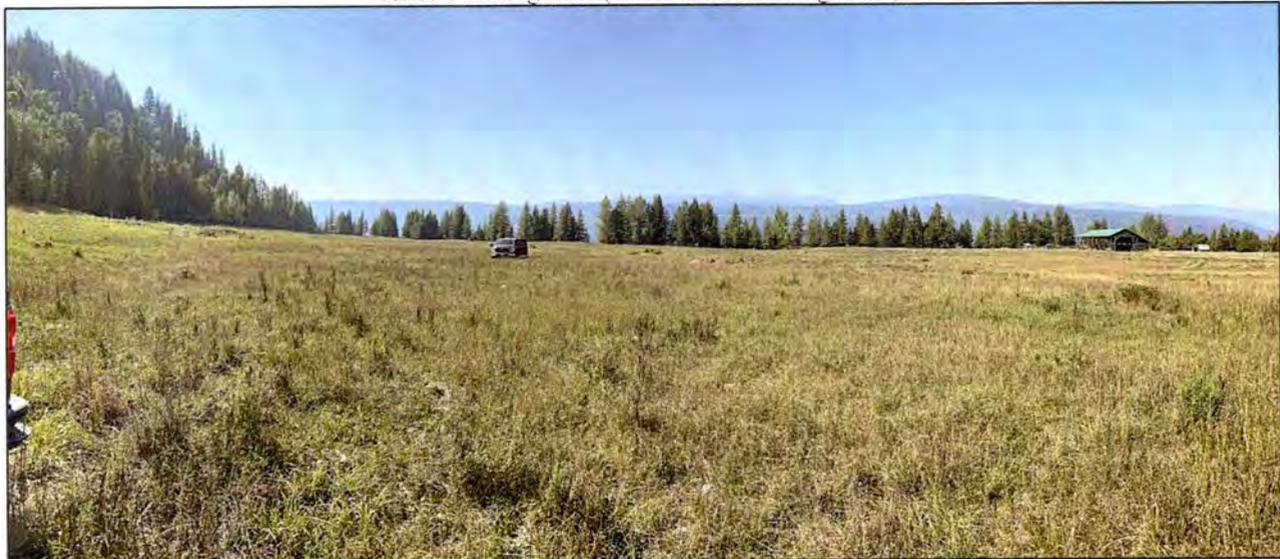
Phase 2 Mining Area (Upper terrace looking south)
