DWB Consulting Services Ltd.

Cottonwood River Protection Works Assessment

Prepared for: Cariboo Regional District
Attn: Stephanie Masun, Alyson Campbell

Prepared by: DWB Consulting Services Ltd.
1579 – 9th Avenue
Prince George, BC V2L 3R8
250.562.5541 | www.dwbconsulting.ca
Date: 31.08.2022 | DWB file: 22619-137 PE | Revision: 1

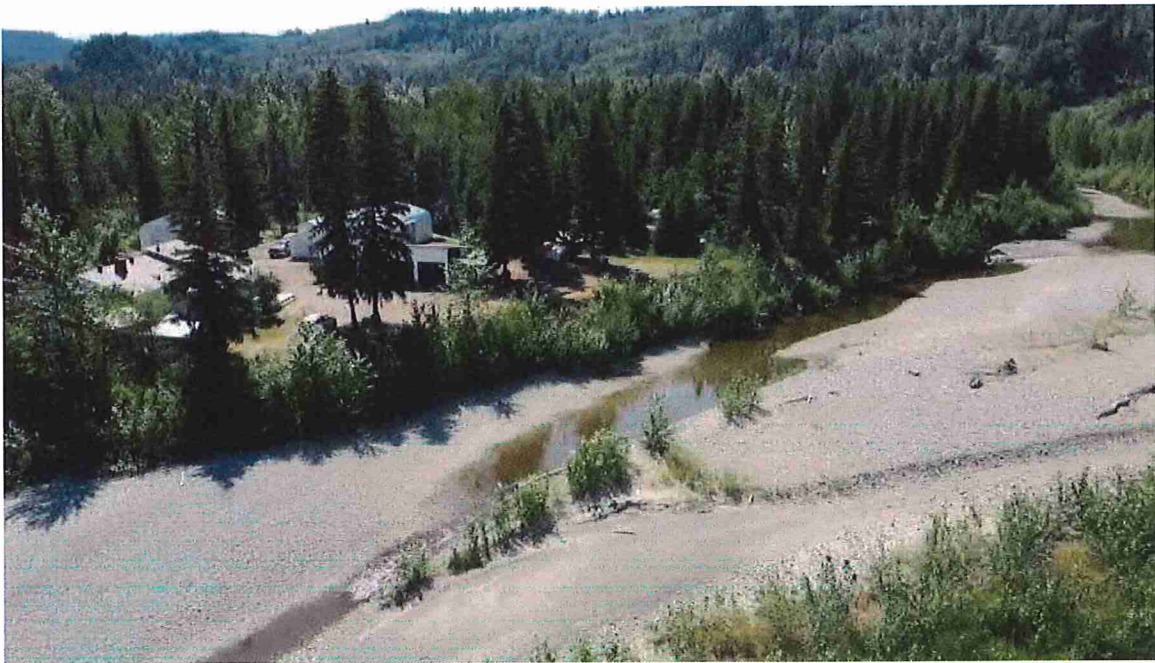
Cottonwood River Bank Protection Spurs

All rock spurs are similar in size, being roughly 2m tall, 5m wide and extending 6 to 7m from top of bank to toe of spur. This matched prescription dimensions. Spurs appear to be constructed of class 250kg riprap with larger key boulders. Riprap appears to be appropriately graded with good embedment and bank key-in. An example of the typical spur is shown in Figure 4, with additional photos in Appendix A. It should be noted that rock spur #1 was difficult to locate and identify due to heavy vegetation and conduction of the staircase. It is not believed that this has compromised the integrity of the spur.

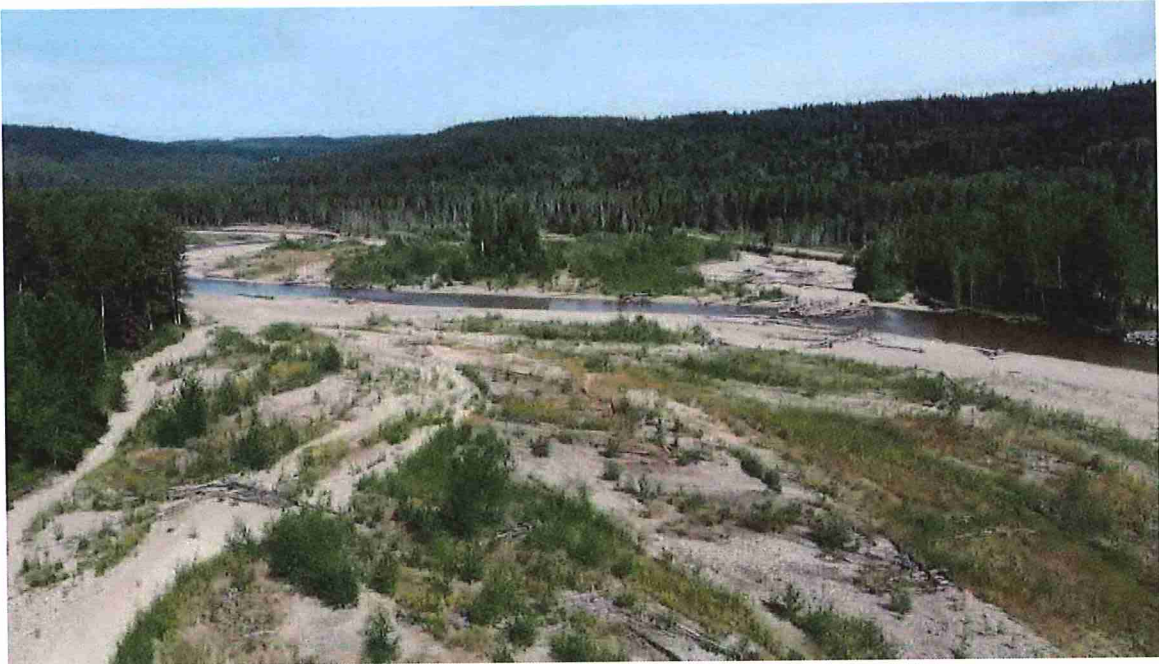
Cottonwood River Floodplains (Looking Downstream, North)

Current channel alignment does not present a direct threat to the properties as the main channel has migrated to the far side of the channel, leaving the home on the inside of the bend. This portion of the channel appears more stable than downstream reaches, due to the tall banks of the west. Vegetation has also begun re-establishing on the gravel bars in front of the properties. It was noted that bank instability further upstream may result in unknown impacts on future channel alignment.

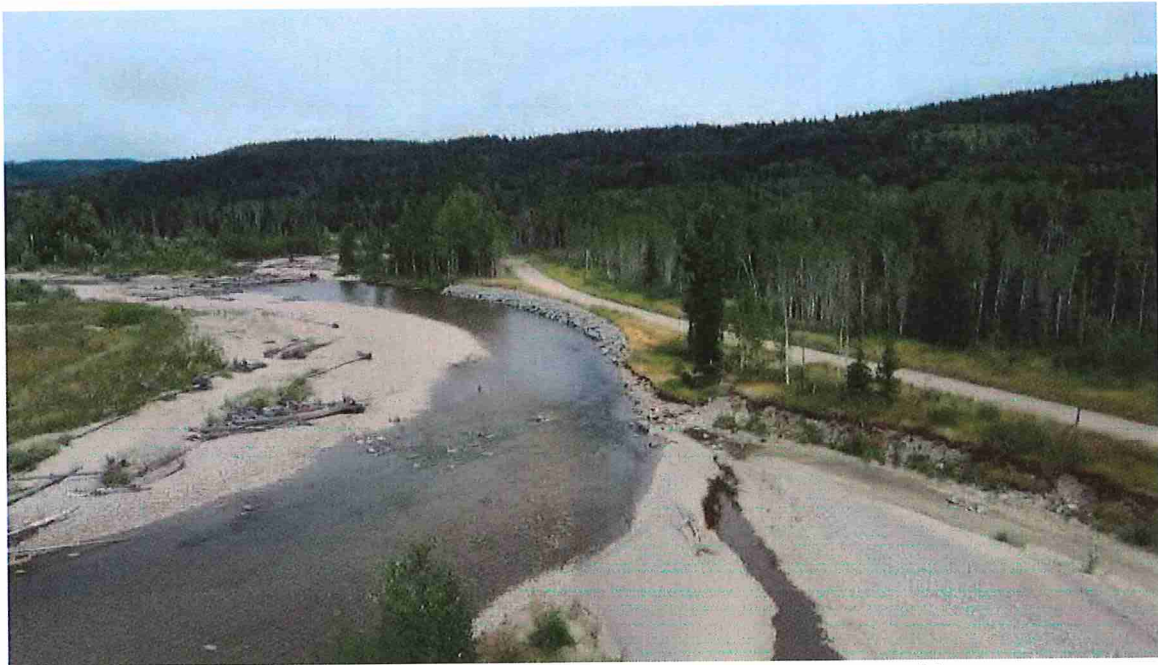
Quesnel-Hixon Road Protection (Looking Downstream, North)

Downstream roadside armouring also appears to be in good condition, with stable slopes, fair gradation, and no identified holes. Minor scour was identified at the top of the riprap; however, it does not appear to be migrating or undermining the armouring at this time. Armouring may be considered by MOTI for road protection if erosion continues.

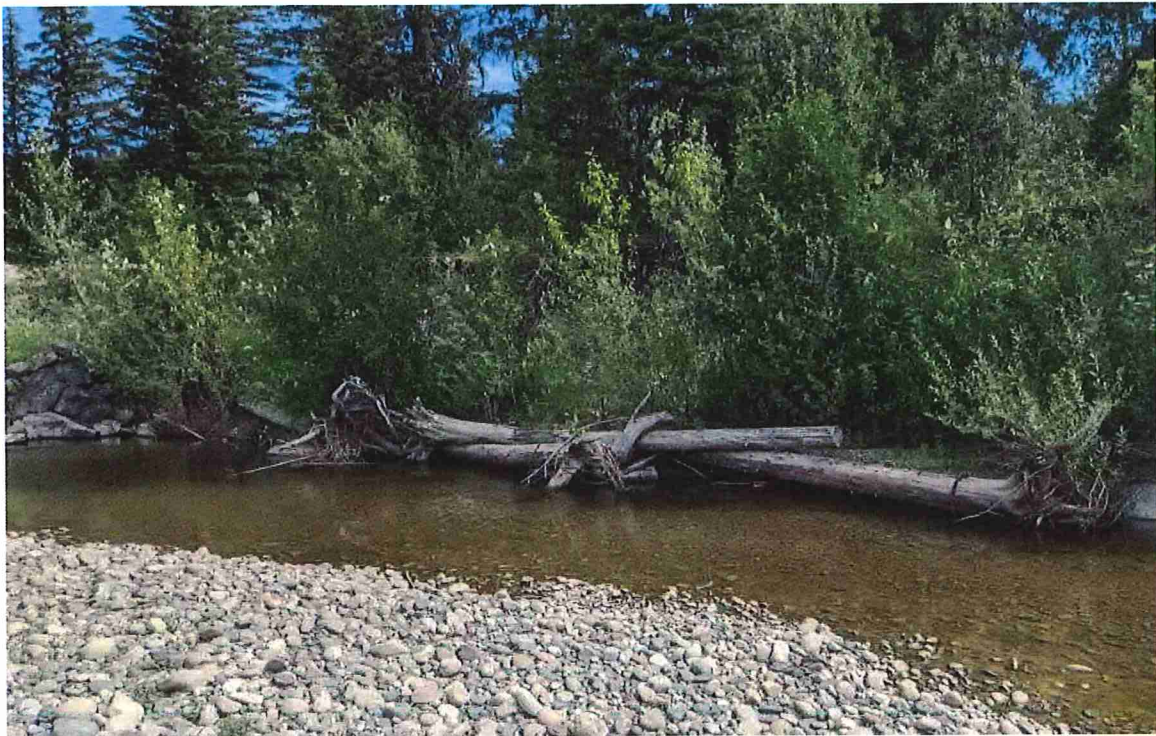
Cottonwood River Bank LWD (Between Spurs 4 & 5)

Large Woody Debris spurs were also constructed (Figure 5), with additional LWD placed along the bank. This debris has been anchored to a core of riprap using bolts and chains. Visible chains are in good condition, with minimal surface rust. Chain connections to the rock anchors were not observed as they were buried in the channel bottom sedimentation. LWD spurs are similar in size to the rock spurs, with additional branch length. Both the rock and LWD spurs are vegetating well.

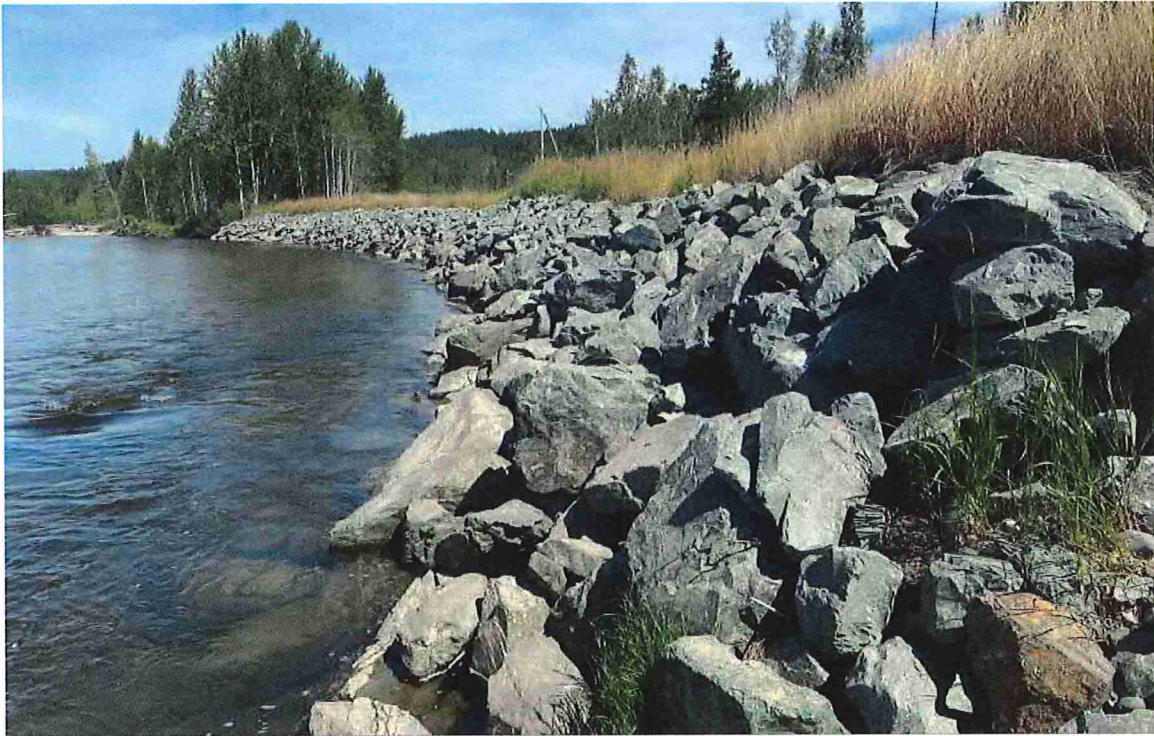
Quesnel-Hixon Road Protection - Riprap (Looking North)

The rock armouring is holding up well and is currently at a stable slope between 1.5:1 and 2:1 as shown in Figure 6. Approximately 6m of grassy shoulder remains at the narrowest point between the rock armouring and the edge of road. Minor erosion with overhanging grasses and small cavities in the native soils was observed above the top of the riprap, however, vegetation suggests this is a minor or slow event.
